NASA Facts

Solid Rocket Boosters and post-launch processing

External Tank Return to Flight Focus Area Thermal Protection System

External Tank Return to Flight Focus Area Forward Bipod Fitting

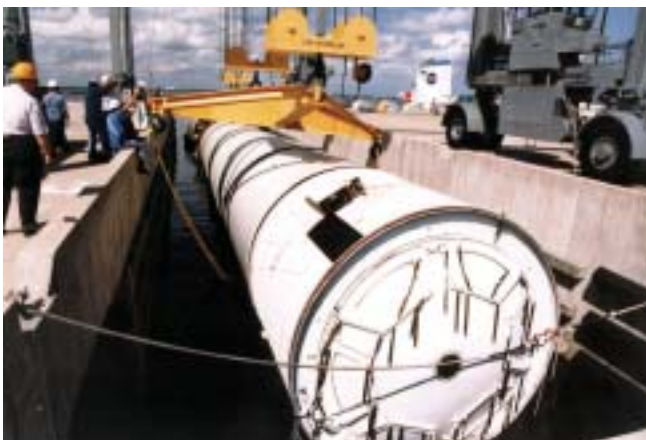
Workers at CCAFS help maneuver the SRB into the hoisting sling.

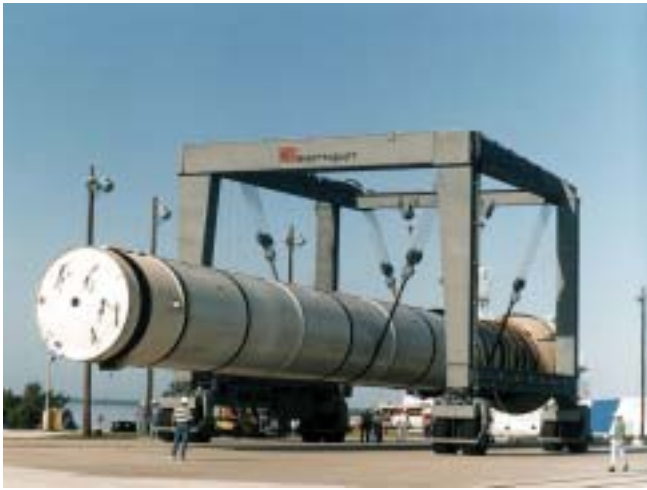
A spent SRB is lifted in a hoisting slip in the Hangar AF area at CCAFS. It will be washed down and moved to the Hangar.

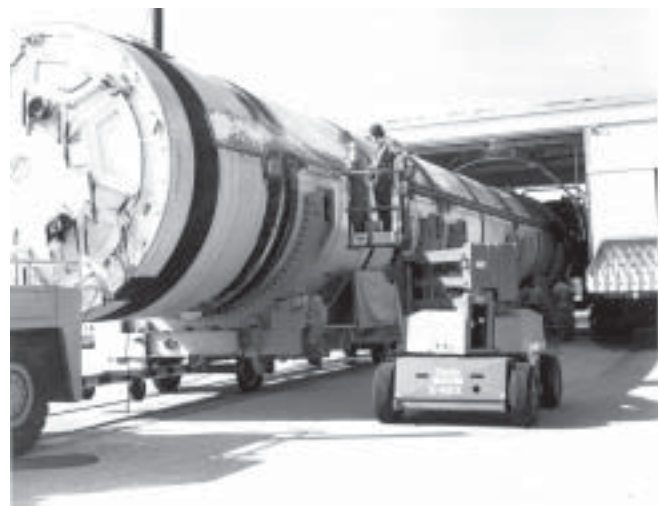
After retrieval post-launch, an SRB is processed through the washing station at Hangar AF.

Hydrolasing requires two workers: one to operate the rotating head gun and the other to act as a safety monitor. The gun operates at 15,000 pounds per square inch, producing an extremely loud sound as the water impacts the SRB. Hearing protection is required to work in and around the area.

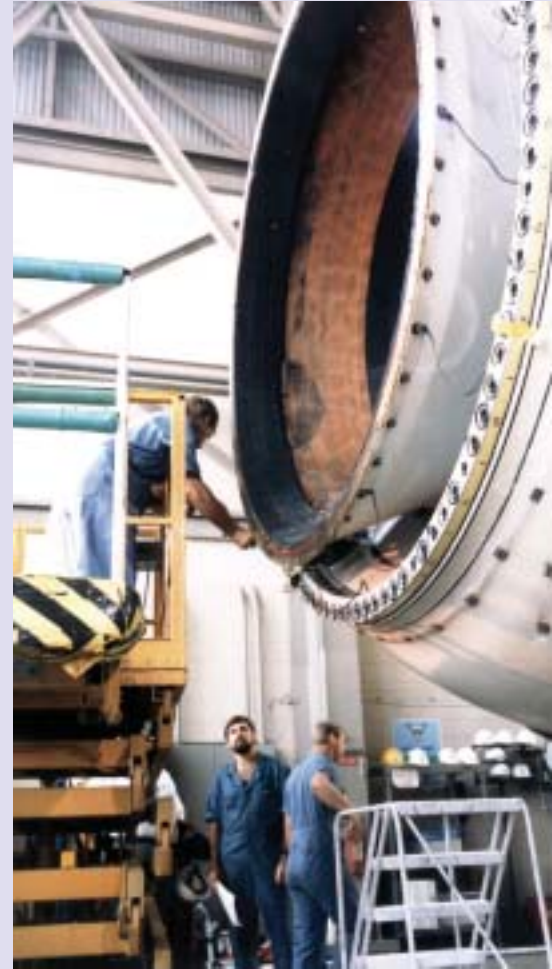
(Far left) Workers at Hangar AF, CCAFS, examine an aft section of an empty SRB.

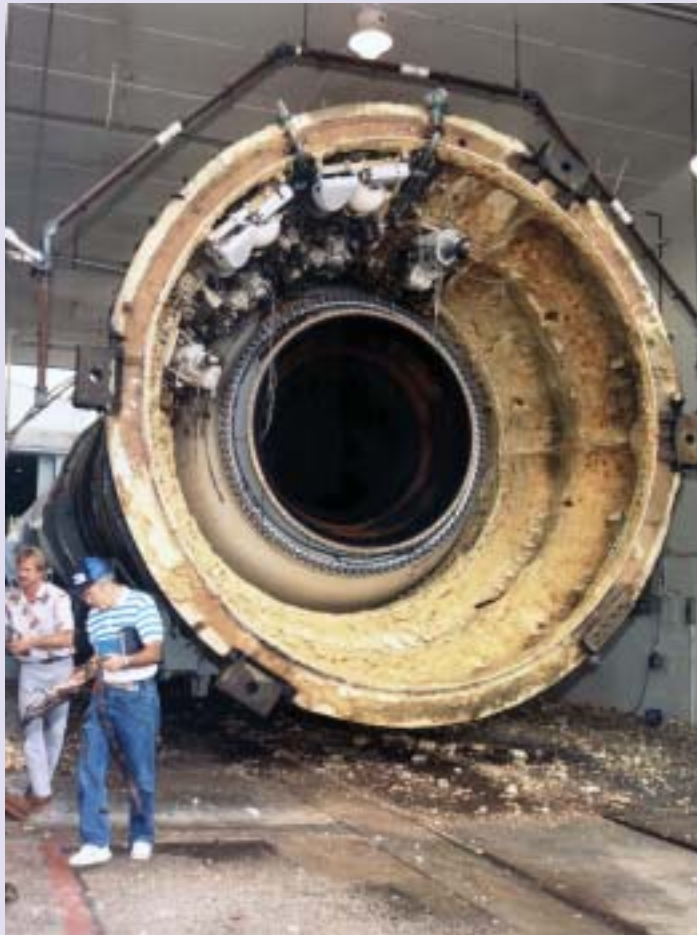
(Left) The segment is in the West Wash area at Hangar AF, CCAFS, on a rail car dolly prior to SRB Aft Skirt demating. Residual aft skirt foam can be seen.

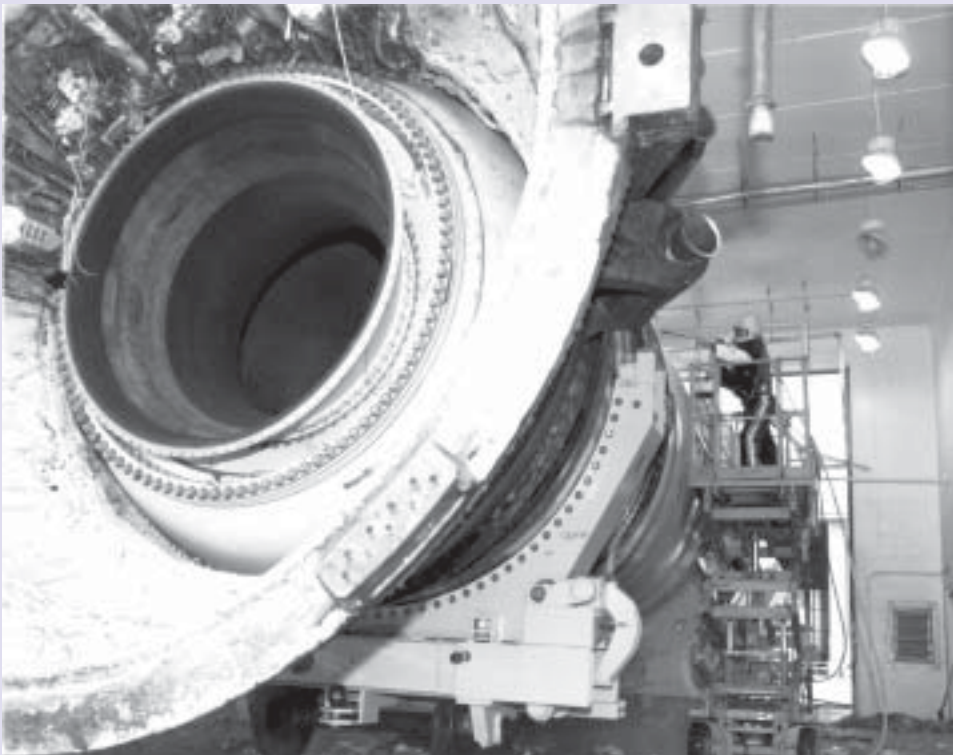
At CCAFS, the frustum of a forward skirt assembly from a spent SRB is removed from the retrieval ship. It will be moved inside Hangar AF High Bay for disassembly.

The frustum was offloaded from the retrieval ship and moved inside the Hangar AF High Bay for disassembly. Various parts, such as the flotation curtains and foam blocks, now are removed. Some parts, like the barometric switch tubes, are sent to "Small Parts," an area inside the Hangar.

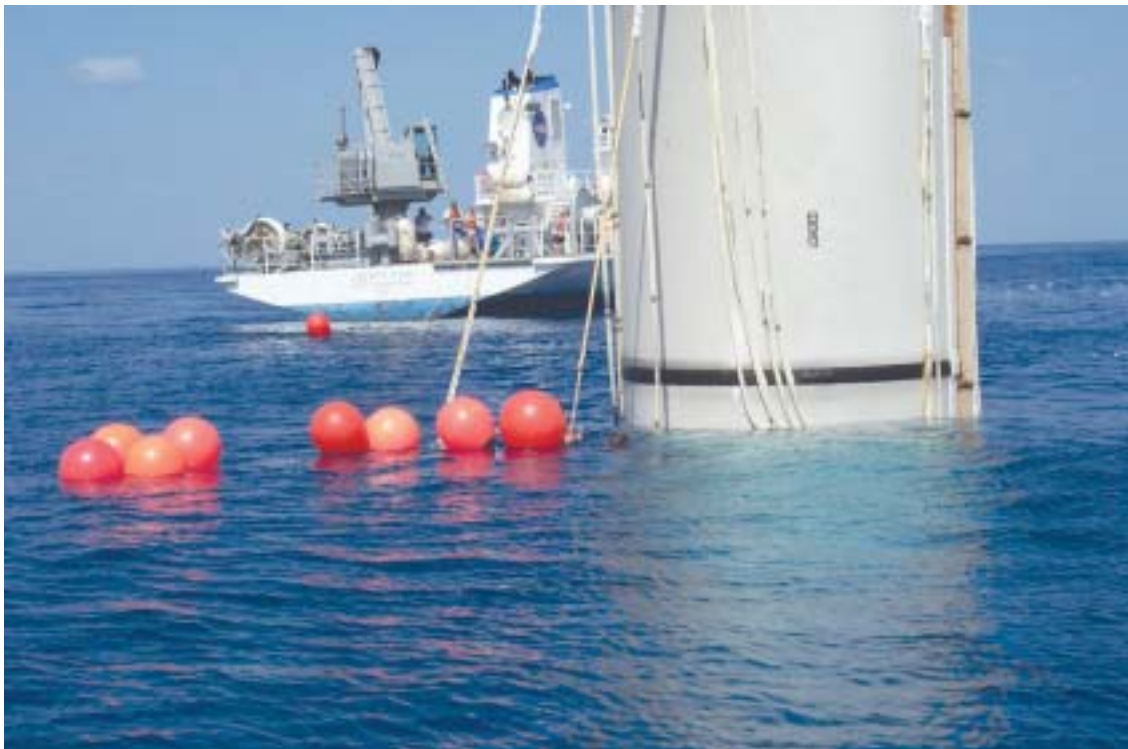
A Solid Rocket Booster Retrieval Ship has arrived on scene after splashdown of an SRB segment following a Space Shuttle launch. The segment floats vertically until divers can insert an Enhanced Diver-Operated Plug (EDOP) into the nozzle of the booster. The EDOP pumps air into the empty casing until all water is expelled and it falls horizontally and can be towed back to port.

Divers plug the nozzle of the SRB with an enhanced diver-operated plug, or EDOP. A 2,000-foot-long airline attached to the EDOP is plugged into an air compressor located onboard the ship. Air is pumped into the booster and forces all the water out, causing the SRB to topple over into a horizontal position. When the flight hardware is safed, the ships return to Hangar AF at Cape Canaveral Air Force Station (CCAFS), Fla., where the disassembly of the Solid Rocket Boosters will begin.

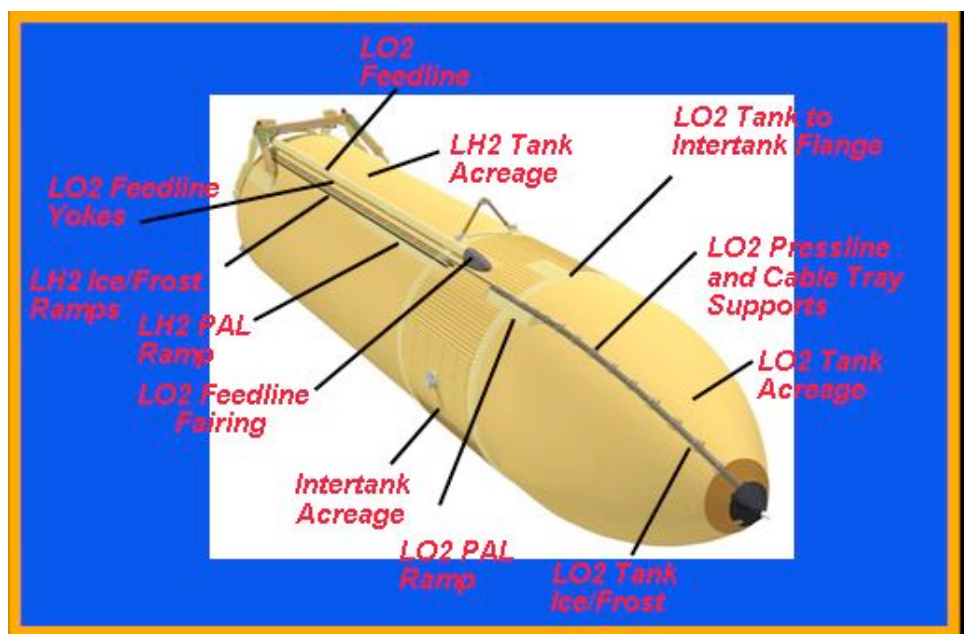
External
Tank
Thermal
Protection
System

The Space Shuttle's External Tank is covered with spray-on foam insulation that serves to insulate the tank before and during launch. The foam is one of two components in the External Tank's Thermal Protection System, or TPS.

There are two basic Thermal Protection Systems on the External Tank: One is low-density, closed-cell foam. The other Thermal Protection System component is a denser composite material called ablator, made of silicone resins and cork. An ablator is a material that dissipates heat by eroding.

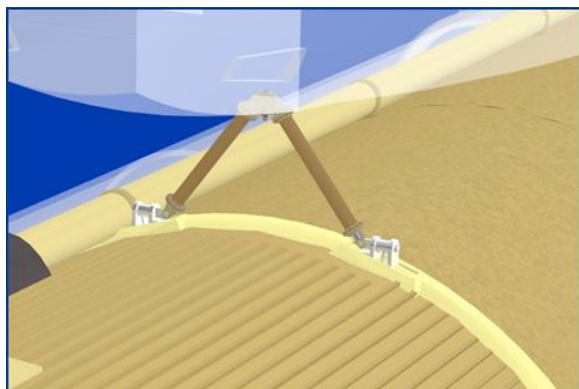
Bipod Location

The insulating foam ramps were in place to prevent ice buildup – another potential debris source -- on the tank's bipod fittings. Each external tank has two bipod fittings that connect the tank to the Orbiter through the Shuttle's two forward attachment struts.

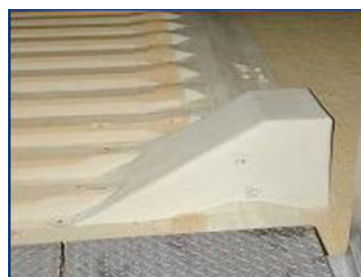
**Bipod
ramp, as
flown**

The bipod ramps were wedge-shaped foam structures, approximately 30 inches long, 14 inches wide and 12 inches tall. The ramps were applied by hand spraying BX250/265 foam over the bipod fittings during the final stages of the tank's preparation. The final ramp shapes were created by hand carving the foam to required dimensions.

Dissection of existing bipod ramps on tanks in inventory conducted during the STS-107 investigation indicated that hand-spraying over the complex geometry of the fittings was prone to produce internal voids and defects. These internal voids and defects have been shown to contribute to foam loss during ascent.

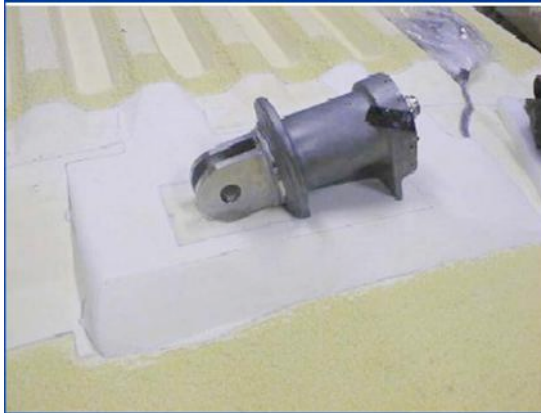
Bipod Redesign

The bipod redesign will allow the fittings to fly mainly exposed --minus the insulating foam ramps. The fittings themselves are the same basic design as before. However, to prevent ice formation while the shuttle sits on the launch pad loaded with extremely cold cryogenic liquid hydrogen fuel, the redesign adds four rod heaters placed below each fitting in a new copper plate. The copper plate with heaters is sandwiched between the fitting and an existing phenolic thermal isolating pad. This thermal isolator helps to reduce heat loss from the copper plate into the extremely cold liquid hydrogen tank.

The heaters are cartridge-type heaters with a wire coil inserted into a tube filled with magnesium oxide. They are 0.25 inches in diameter and 5 inches in length. Each heater can produce up
