**Appendix C-SSME Historic Photos**

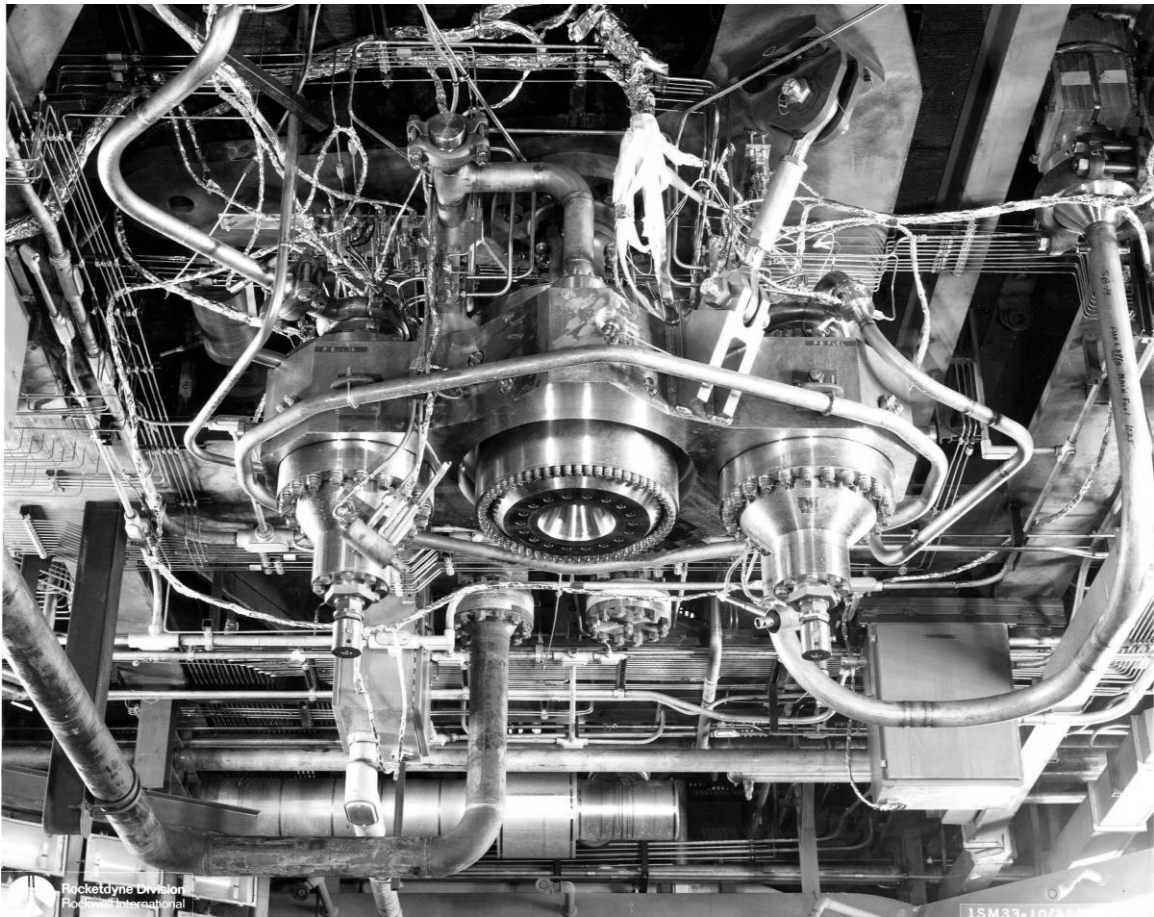
Figure C-1. SSME Solid Wall Hot Gas Manifold installed in Coca IV Test Stand, SSFL,  
direction unknown, October 31, 1974.  
Source: Boeing Company/Santa Susana Field Laboratory, Photo No. 00395.

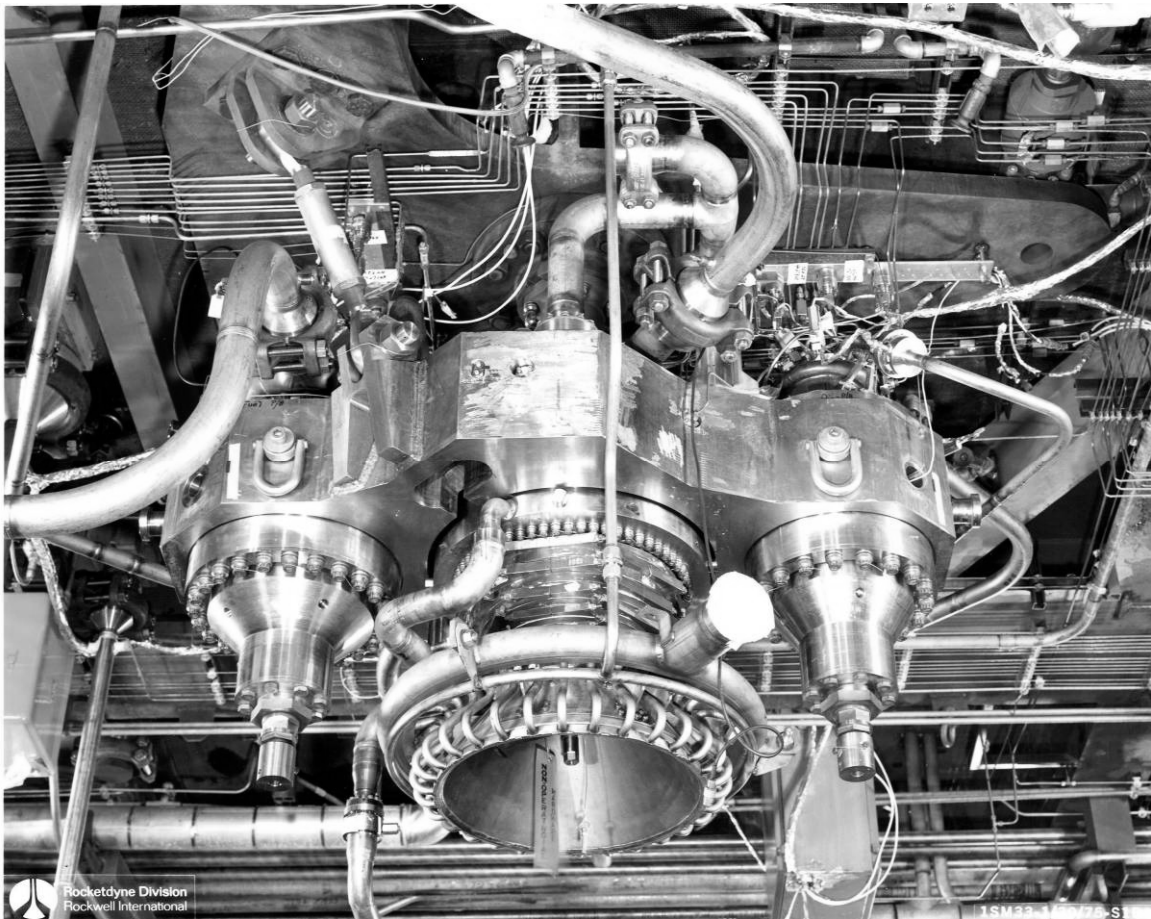
Figure C-2. SSME Solid Wall Hot Gas Manifold, with Main Combustion Chamber, installed in Coca IV Test Stand, SSFL, direction unknown, January 20, 1975.  
Source: Boeing Company/Santa Susana Field Laboratory, Photo No. 00397.

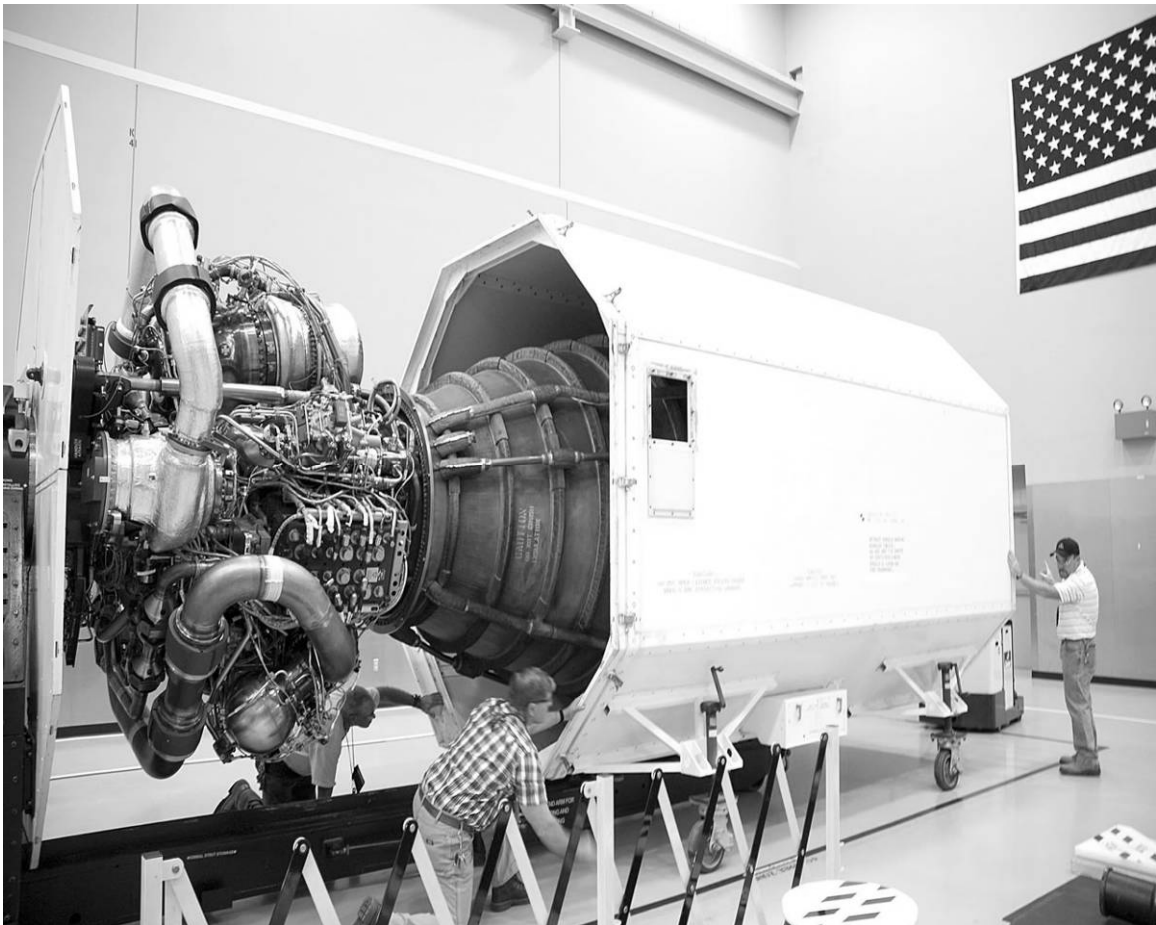
Figure C-4. Arrival of a SSME at SSC for testing, direction unknown, October 1, 2008.  
Source: John C. Stennis Space Center, SIRS, SSC-2008-01788, accessed at  
<http://www.ssc.nasa.gov/sirs/scripts/xmlWelcome.pl>.

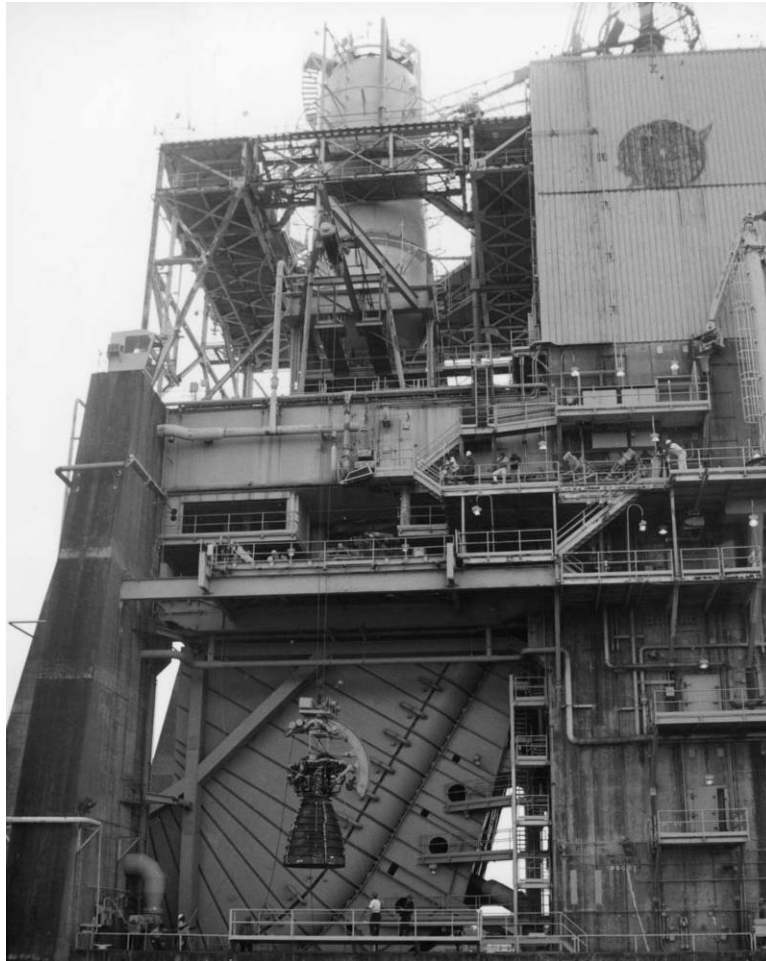
Figure C-5. A SSME being lifted into Stand A-2 at SSC for testing, camera facing east, 1996.  
Source: John C. Stennis Space Center, SIRS, 96-427-13, accessed at  
<http://www.ssc.nasa.gov/sirs/scripts/xmlWelcome.pl>.

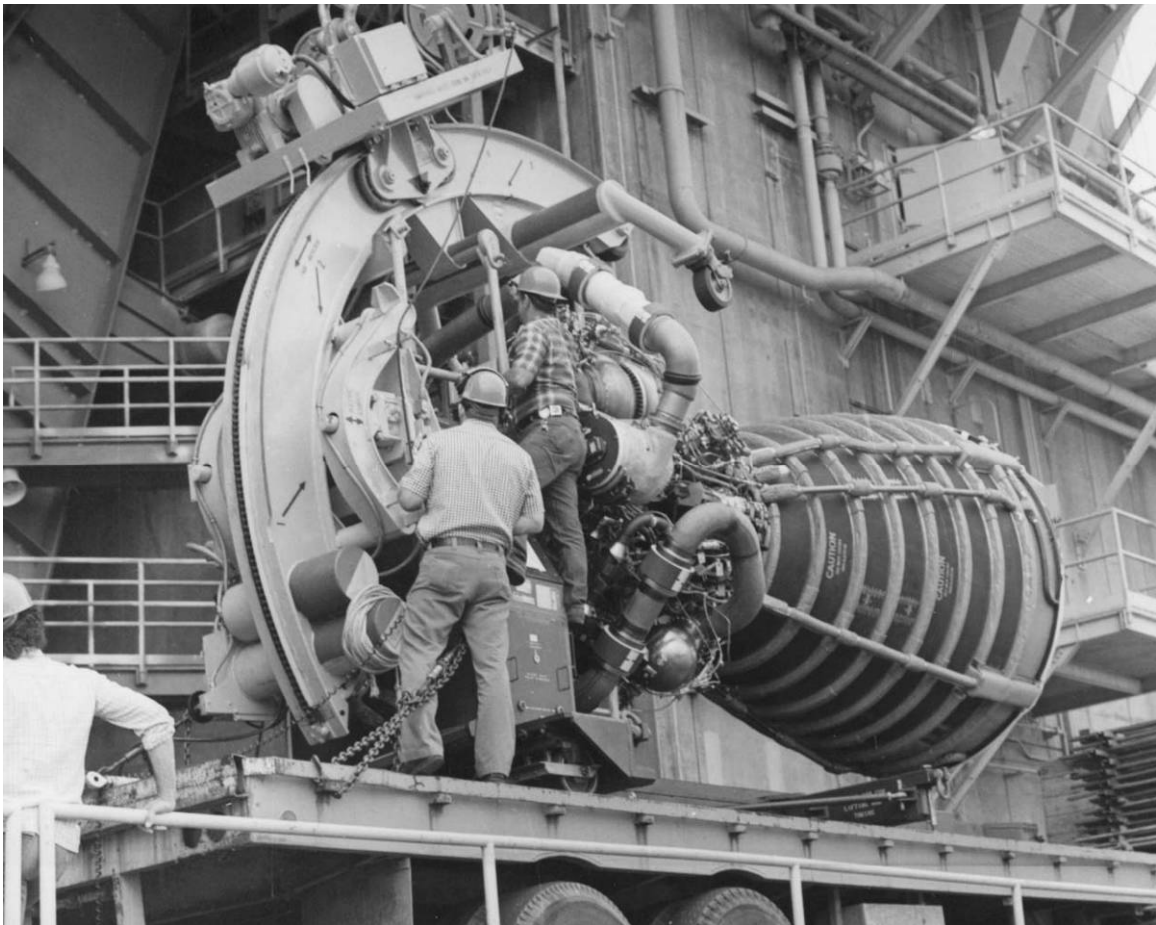
Figure C-6. Hoisting a SSME into SSC Test Stand A-2, direction unknown, 1979.  
Source: John C. Stennis Space Center, Stennis Image Retrieval System (SIRS), 79-116-7,  
accessed at <http://www.ssc.nasa.gov/sirs/scripts/xmlWelcome.pl>.

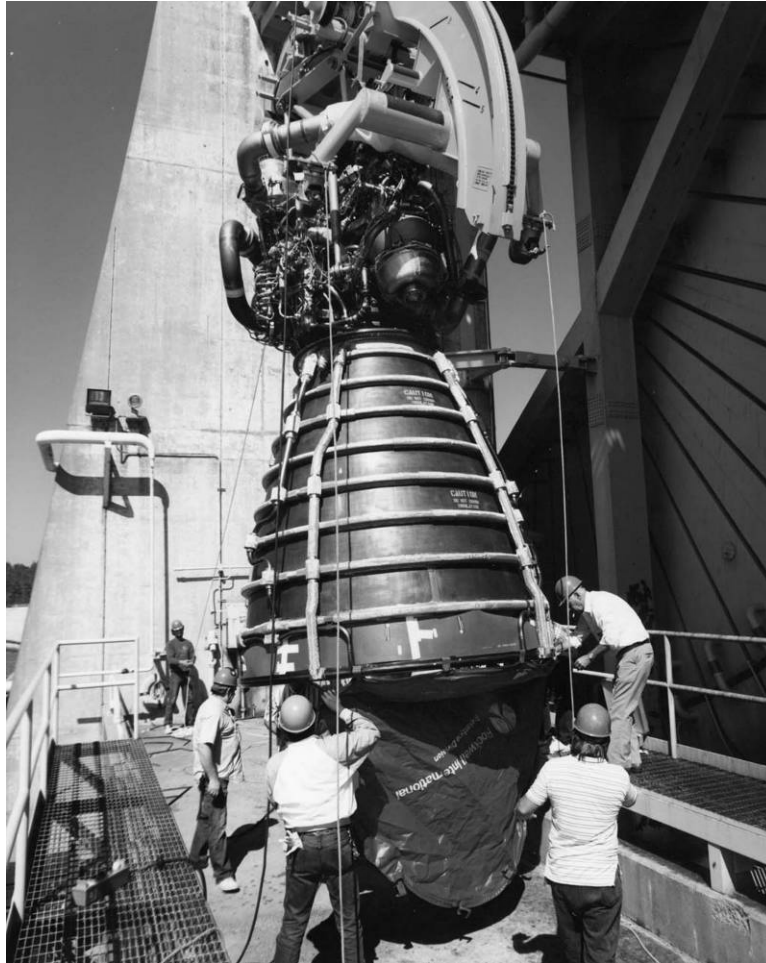
Figure C-7. Hoisting a SSME into SSC Test Stand A-2, camera facing north, 1990.  
Source: John C. Stennis Space Center, Stennis Image Retrieval System (SIRS), 90-548-15,  
accessed at <http://www.ssc.nasa.gov/sirs/scripts/xmlWelcome.pl>.

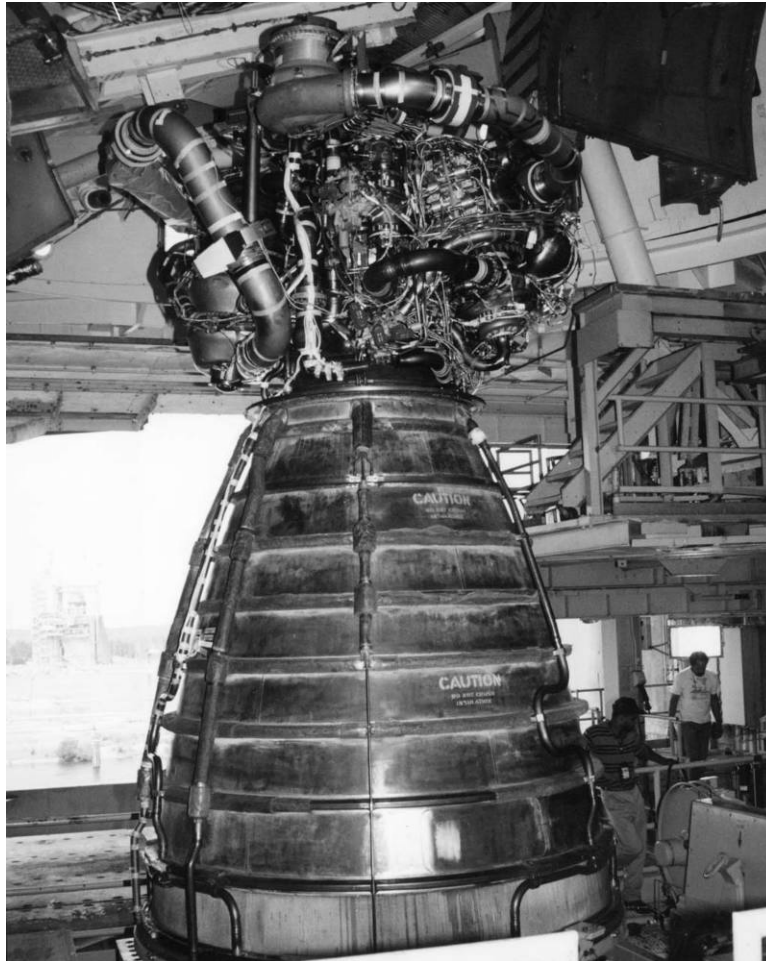
Figure C-8. Installing a SSME into SSC Test Stand A-2, camera facing northwest, 1996.  
Source: John C. Stennis Space Center, SIRS, 96-430-19, accessed at  
<http://www.ssc.nasa.gov/sirs/scripts/xmlWelcome.pl>.

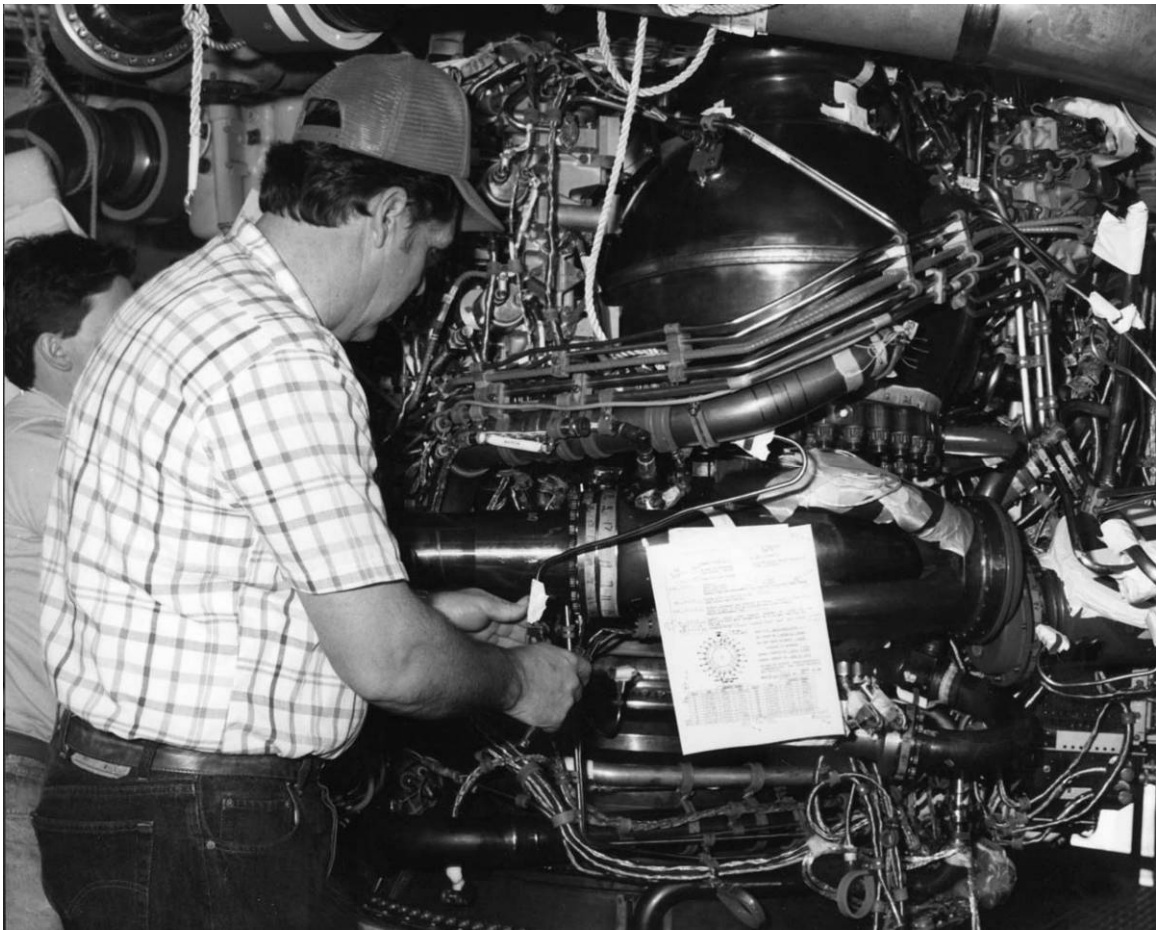
Figure C-9. Preparing a SSME for testing, direction unknown, 1989.  
Source: John C. Stennis Space Center, SIRS, 89-082-4, accessed at  
<http://www.ssc.nasa.gov/sirs/scripts/xmlWelcome.pl>.

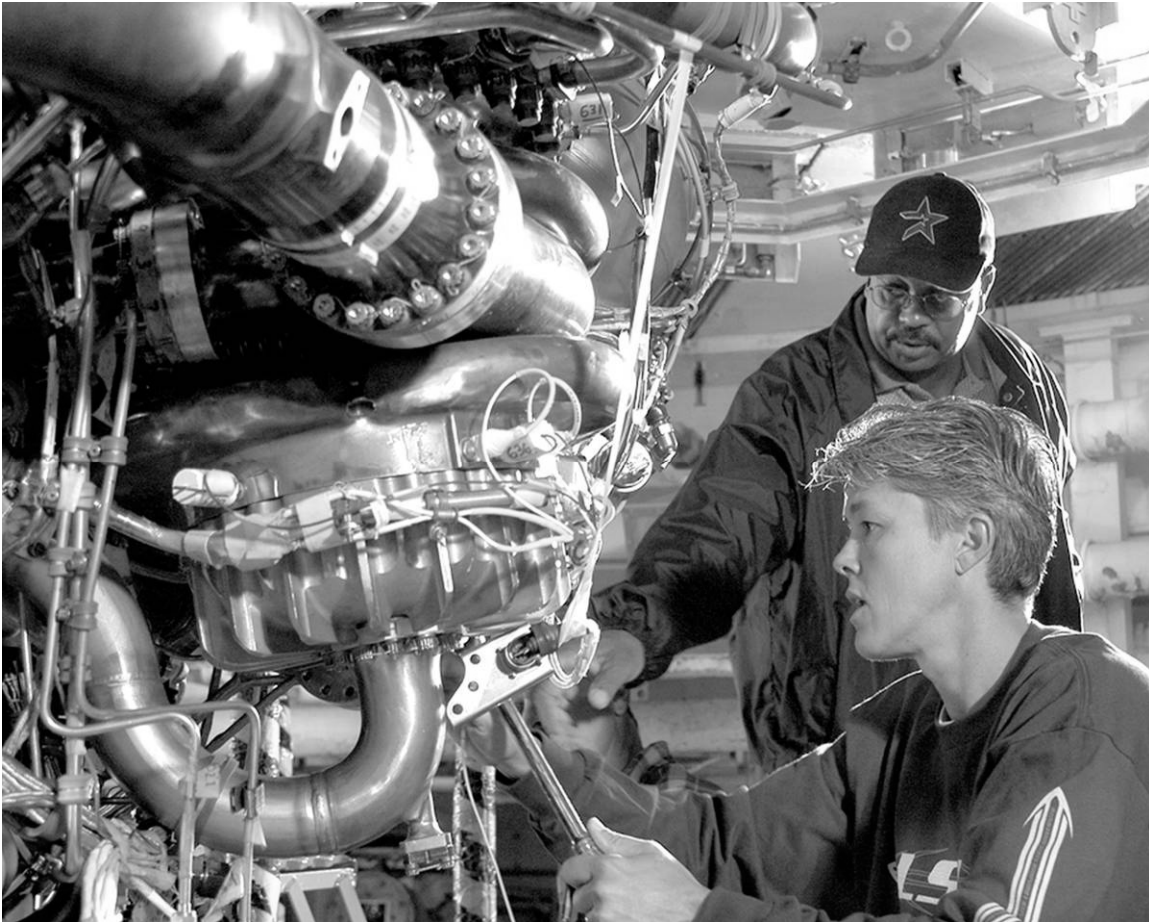
Figure C-10. Final preparations being made to a SSME for testing, direction unknown, October 25, 2005.

(Note: This is the first engine to be tested at SSC following Hurricane Katrina.)

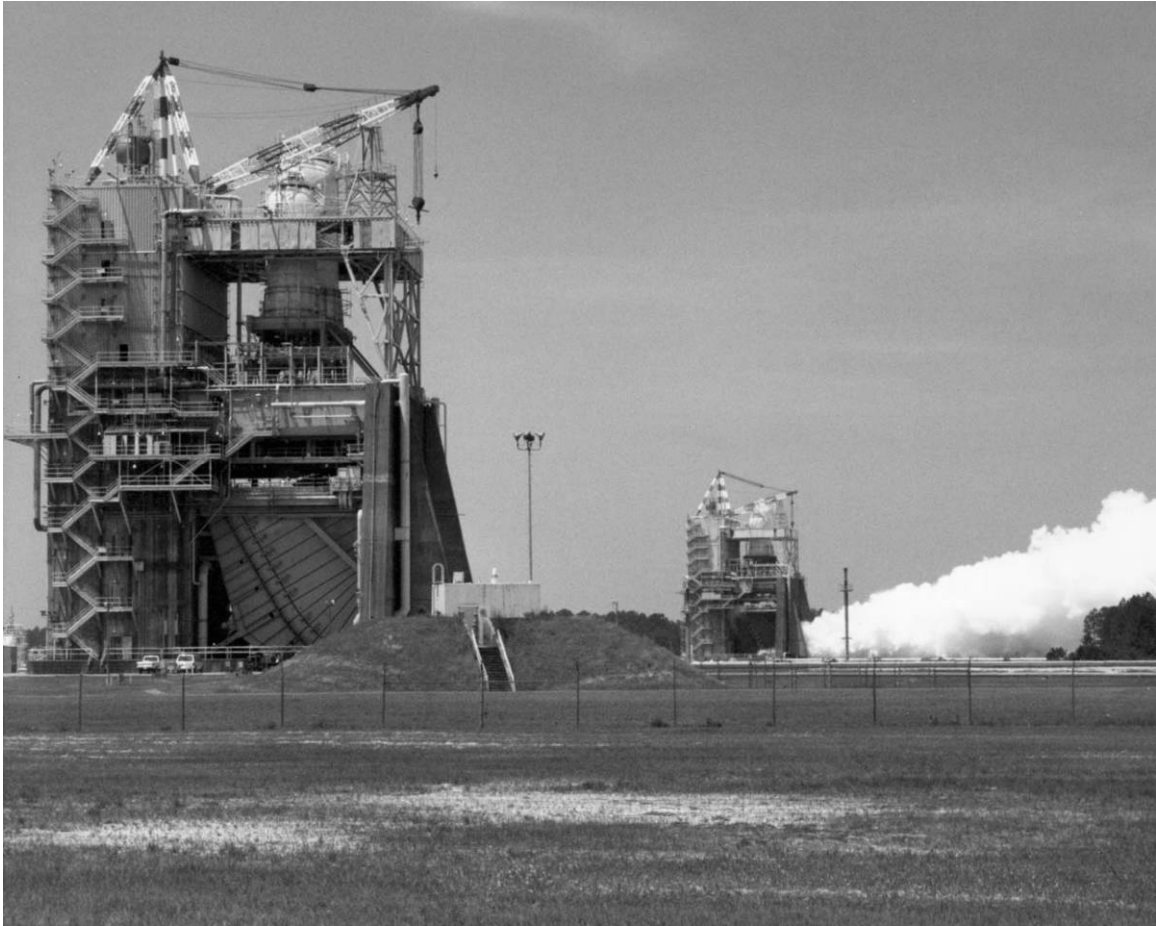
Figure C-11. A SSME undergoing testing on Stand A-1 (Stand A-2 in the foreground), camera facing southwest, 1987.

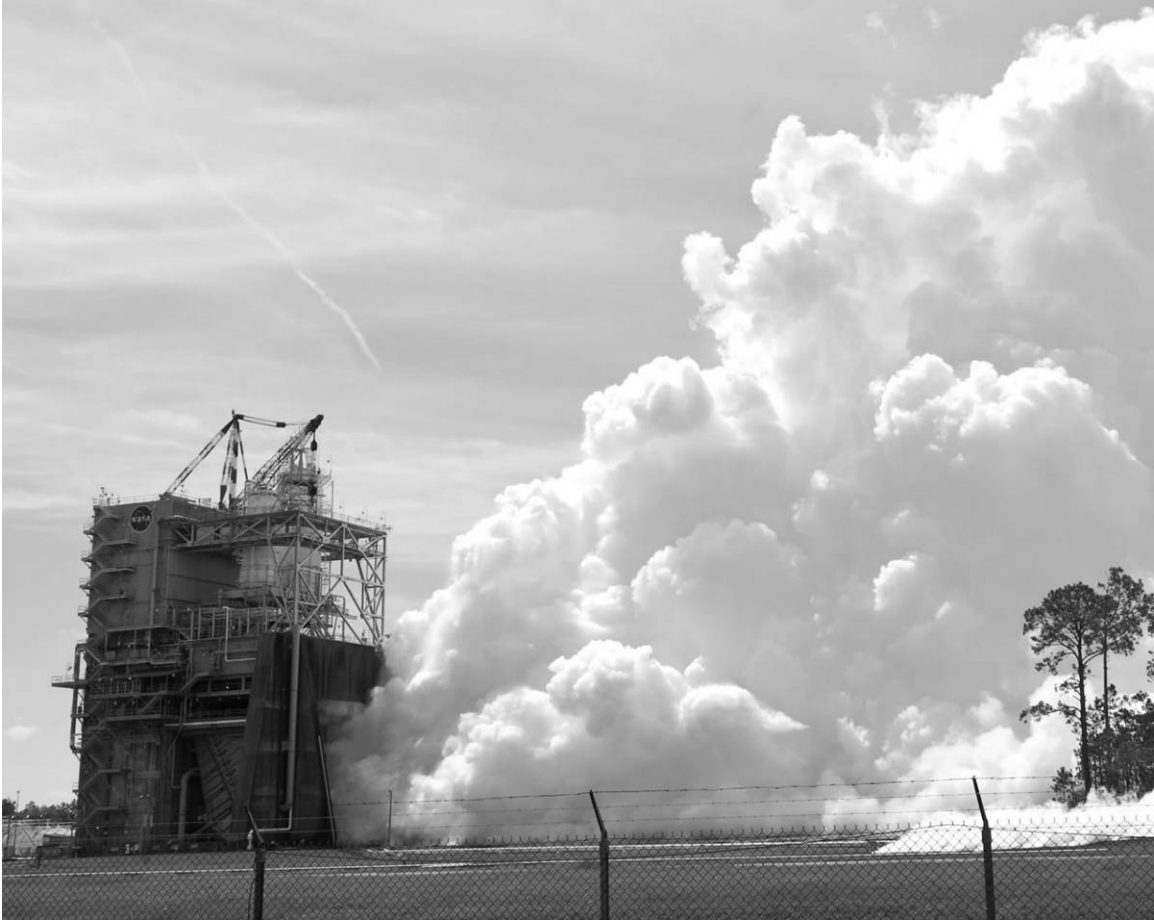
Figure C-12. A SSME undergoing testing on Stand A-2, camera facing southwest,  
March 30, 2009.

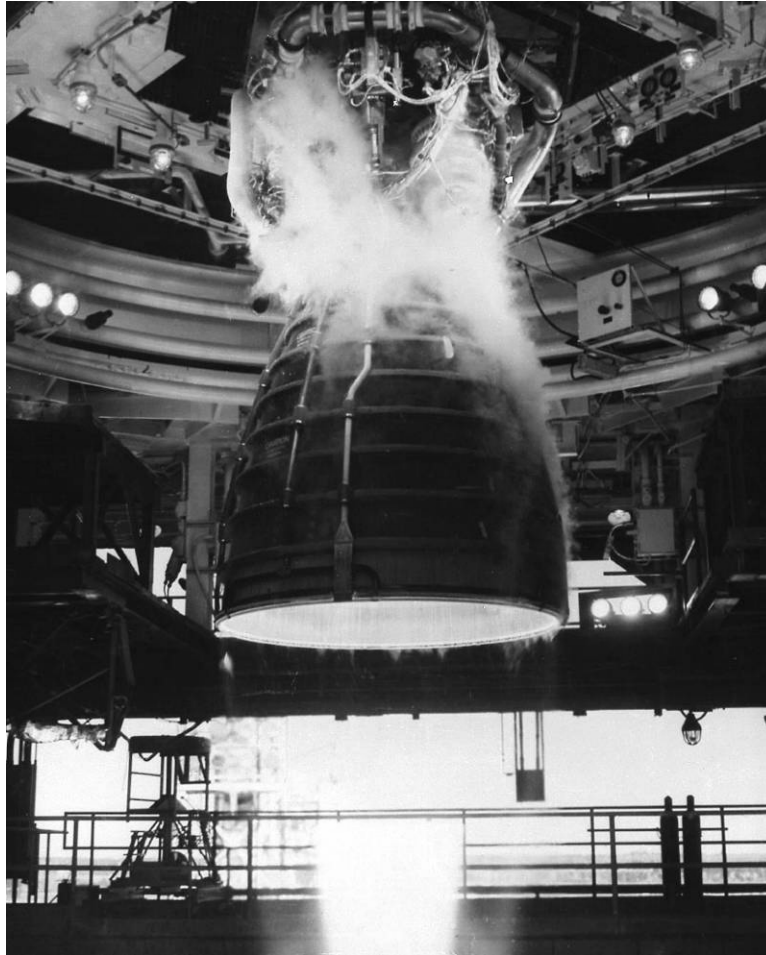
Figure C-13. Close-up view of a SSME test, direction unknown, April 1, 1979.  
Source: George C. Marshall Space Flight Center, Marshall Image Exchange (MIX), 7995081,  
accessed at <http://mix.msfc.nasa.gov/>.

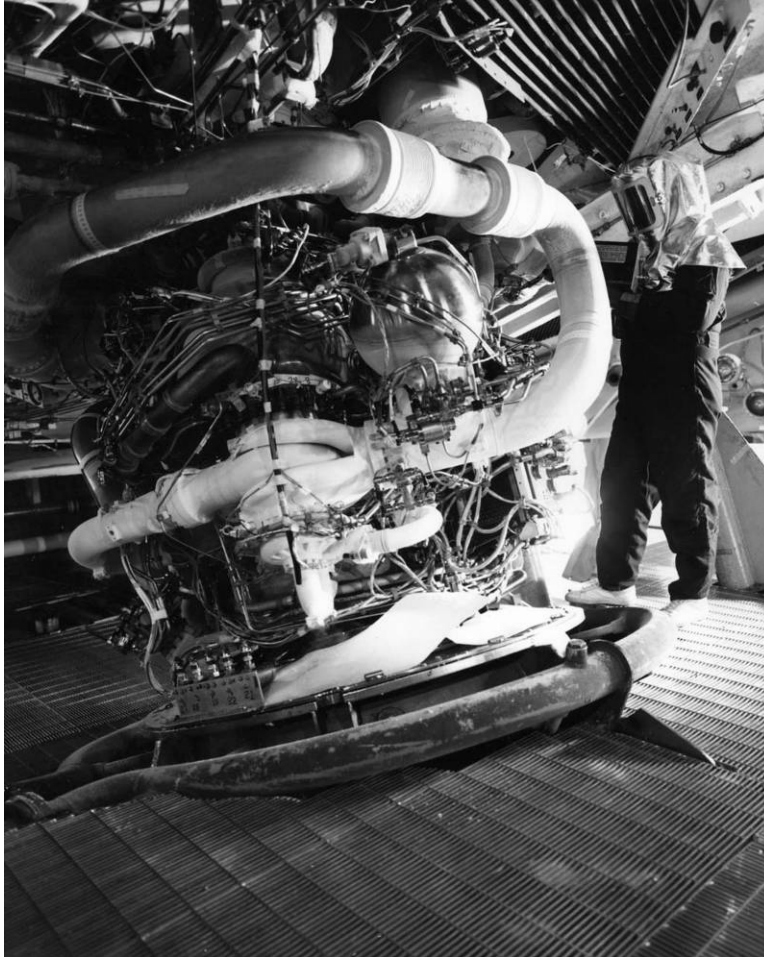
Figure C-15. Post-test inspection of a SSME, direction unknown, 1991.  
Source: John C. Stennis Space Center, SIRS, 91-080-27, accessed at  
<http://www.ssc.nasa.gov/sirs/scripts/xmlWelcome.pl>.

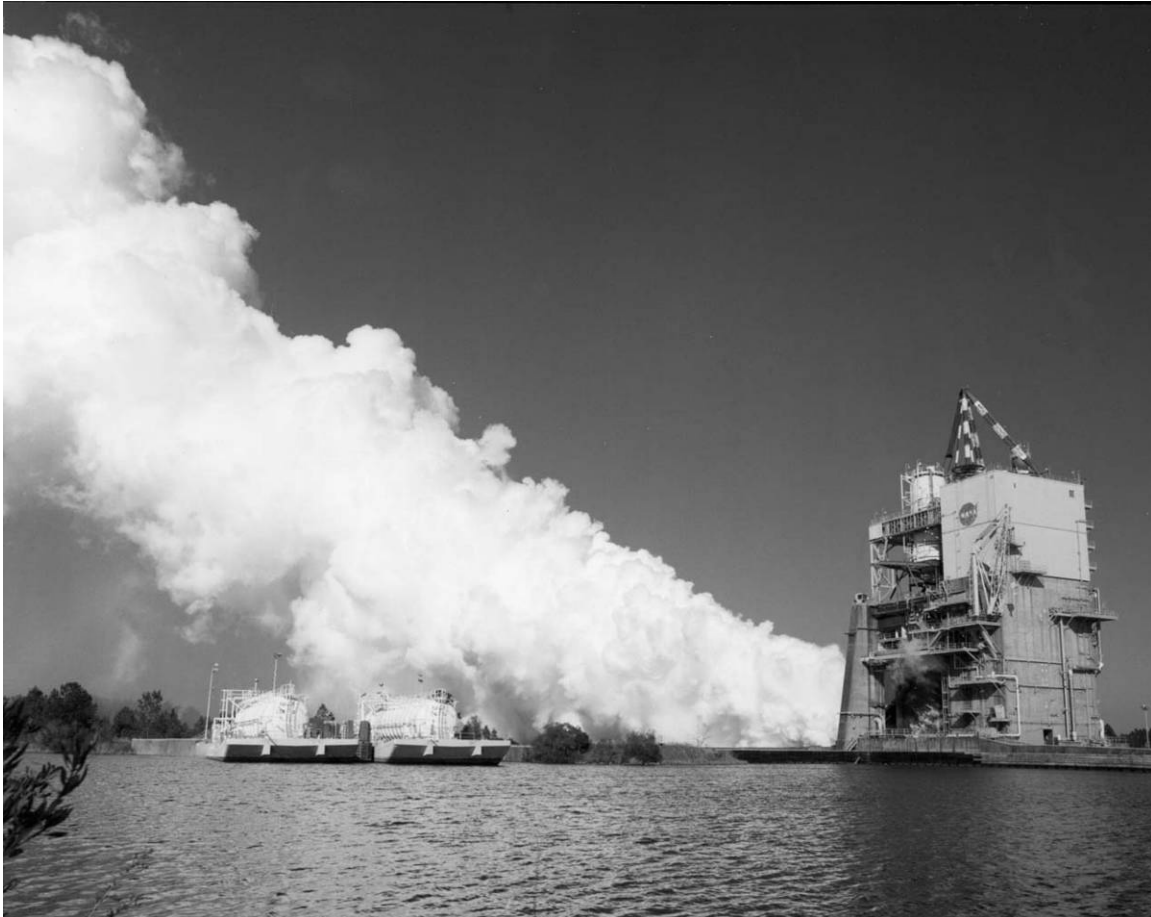
Figure C-16. A “Return to Flight,” Phase II SSME undergoing testing on Stand A-1, camera facing northeast, 1988.

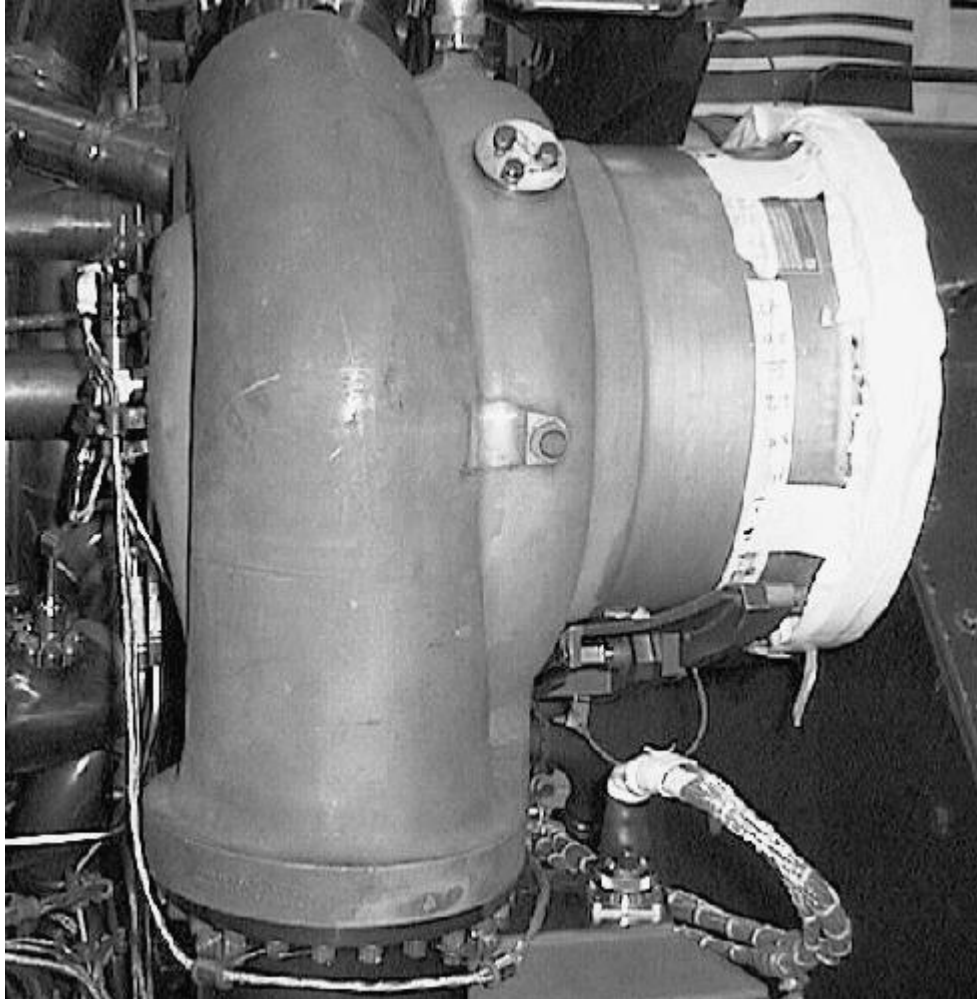
Figure C-19. SSME Low Pressure Oxidizer Turbopump.  
Source: George C. Marshall Space Flight Center.

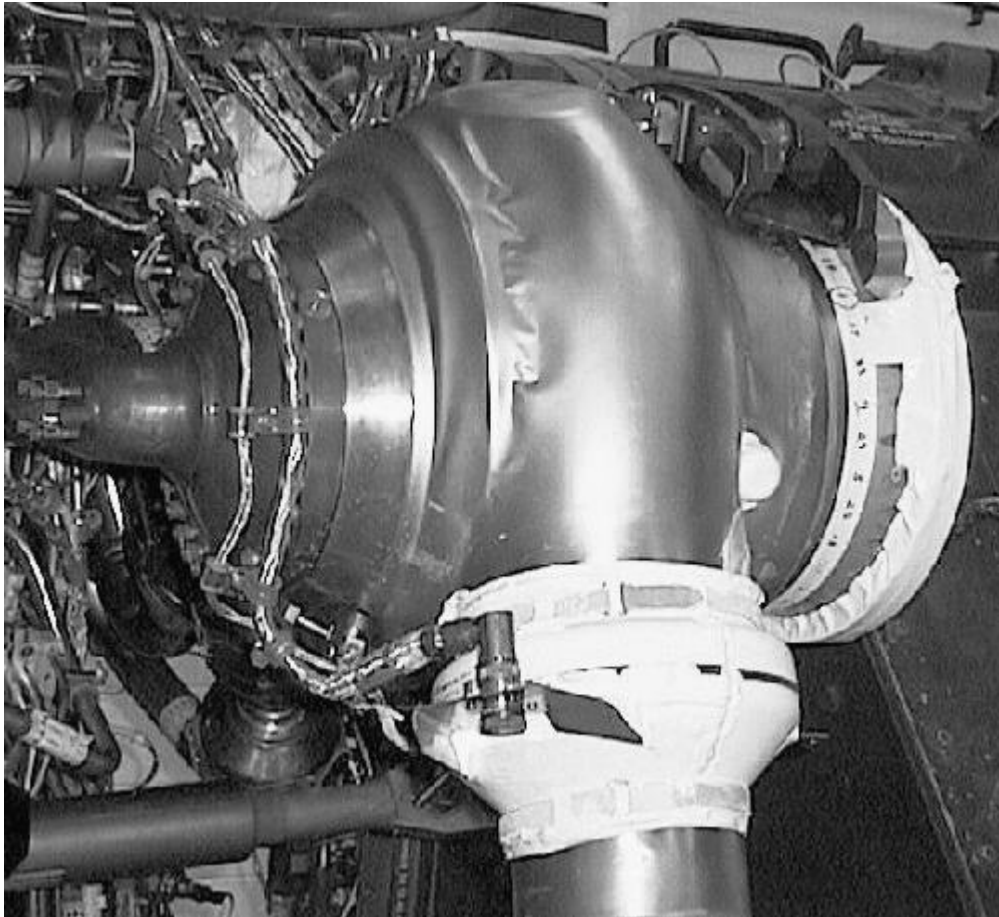
Figure C-20. SSME Low Pressure Fuel Turbopump.  
Source: George C. Marshall Space Flight Center.

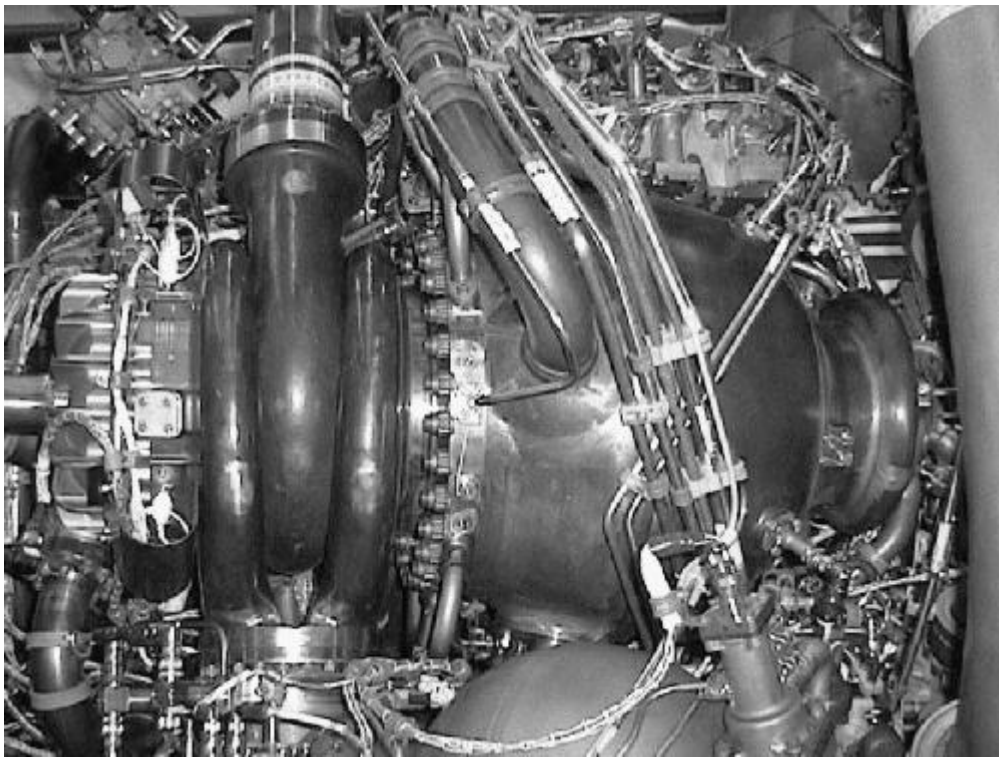
Figure C-21. SSME High Pressure Oxidizer Turbopump.  
Source: George C. Marshall Space Flight Center.

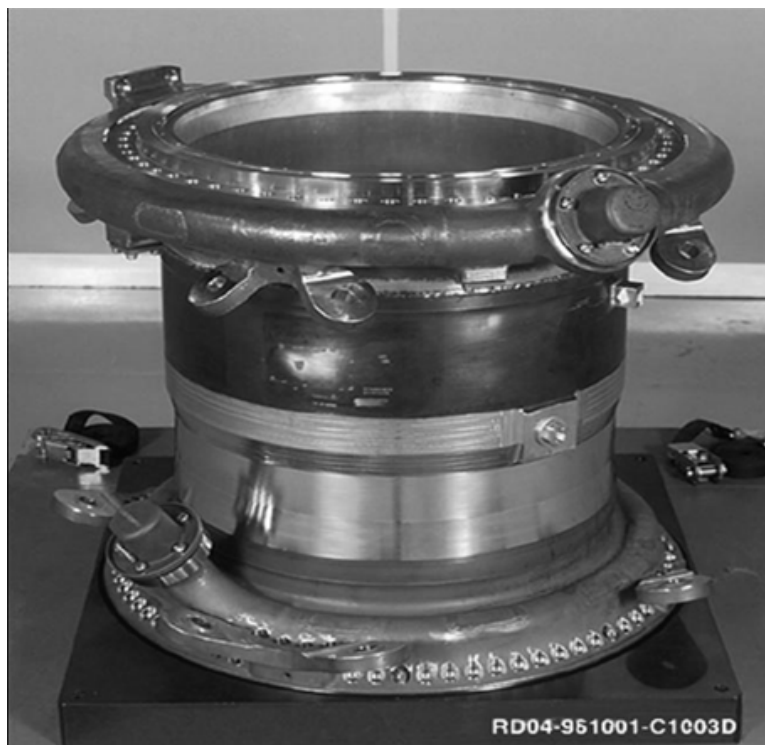
Figure C-23. SSME Main Combustion Chamber.  
Source: George C. Marshall Space Flight Center.

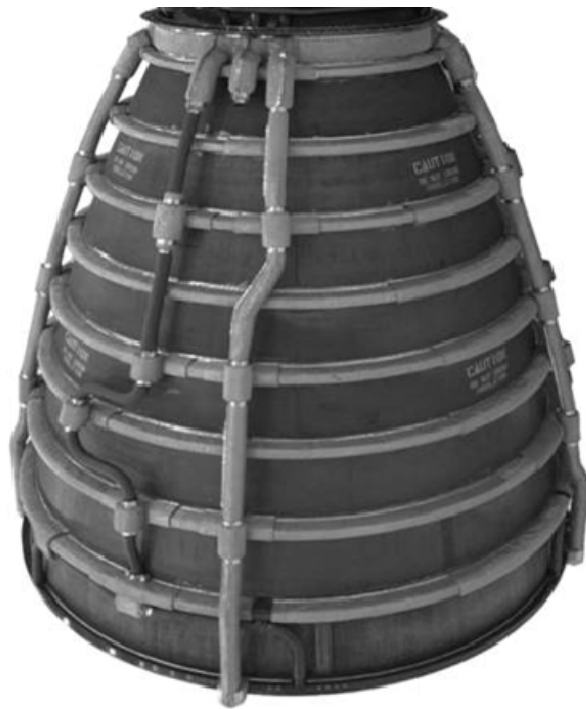
Figure C-24. SSME Nozzle.  
Source: George C. Marshall Space Flight Center.

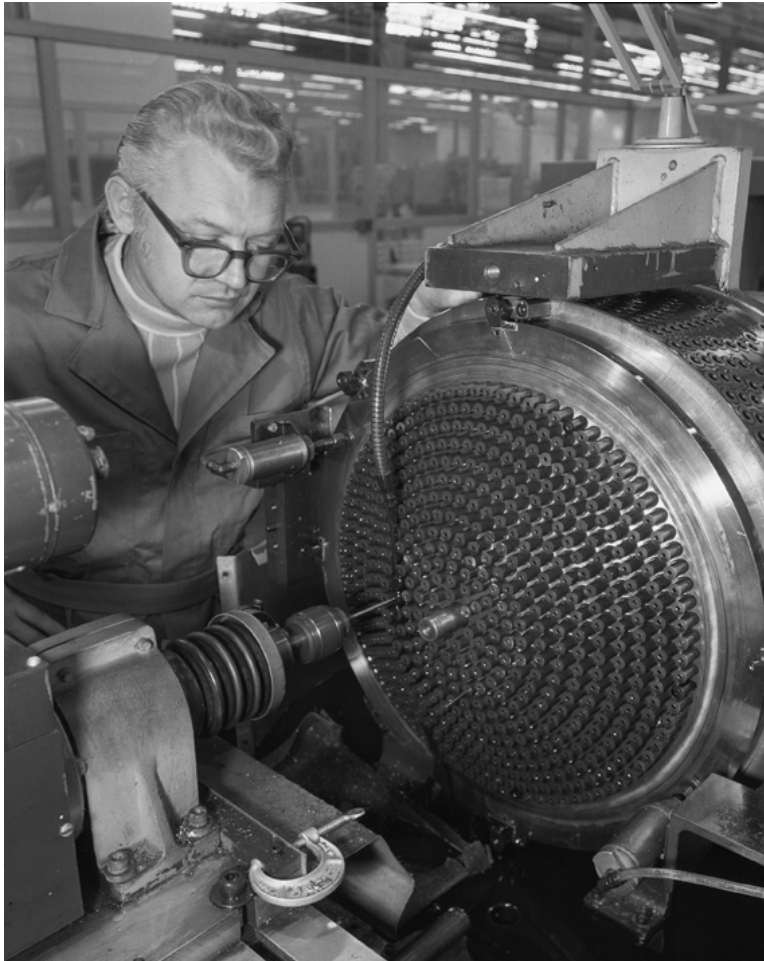
Figure C-25. A technician reams holes into the SSME main injector body at Rocketdyne's Canoga Park, California, facility, direction unknown, August 1, 1978.  
Source: George C. Marshall Space Flight Center, Marshall Image Exchange (MIX), 7779474, accessed at <http://mix.msfc.nasa.gov/>.

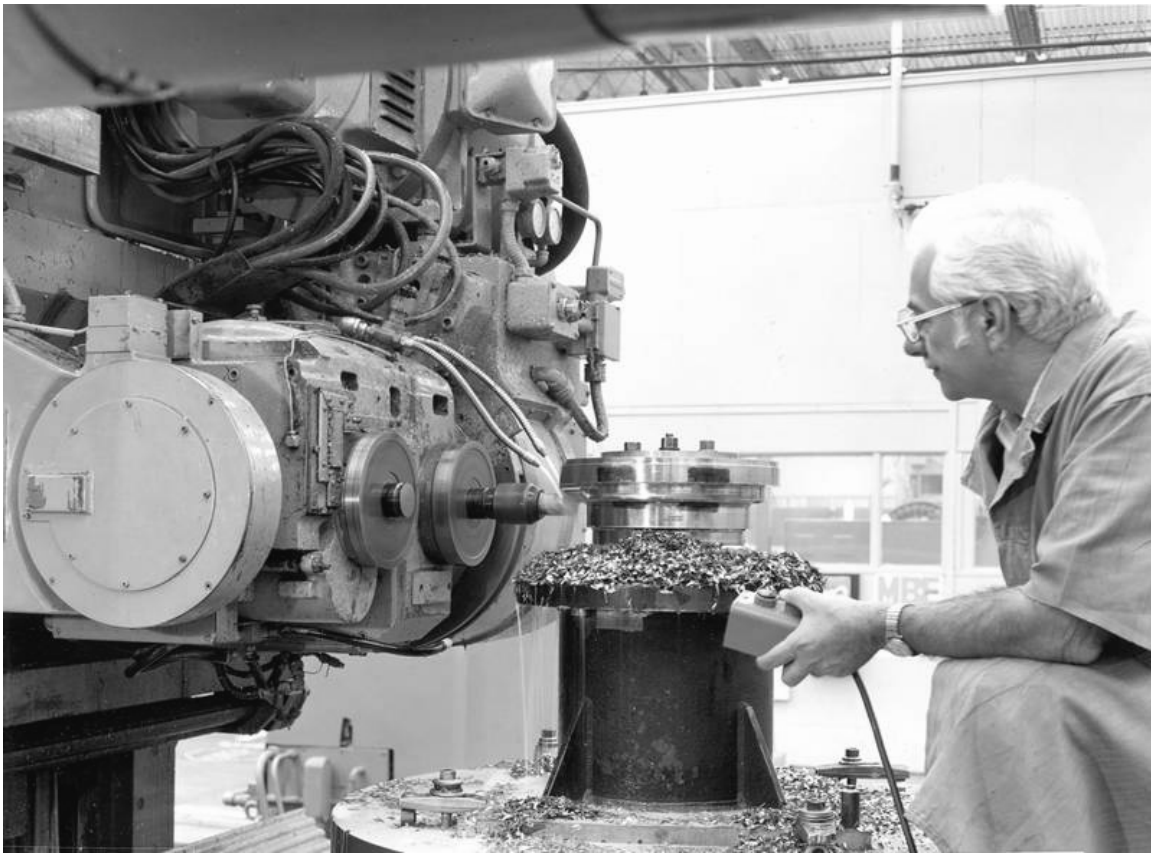
Figure C-26. A technician machining a SSME Oxidizer Preburner Body on the 5-Axis Omni Mill, Canoga Park, 1973.

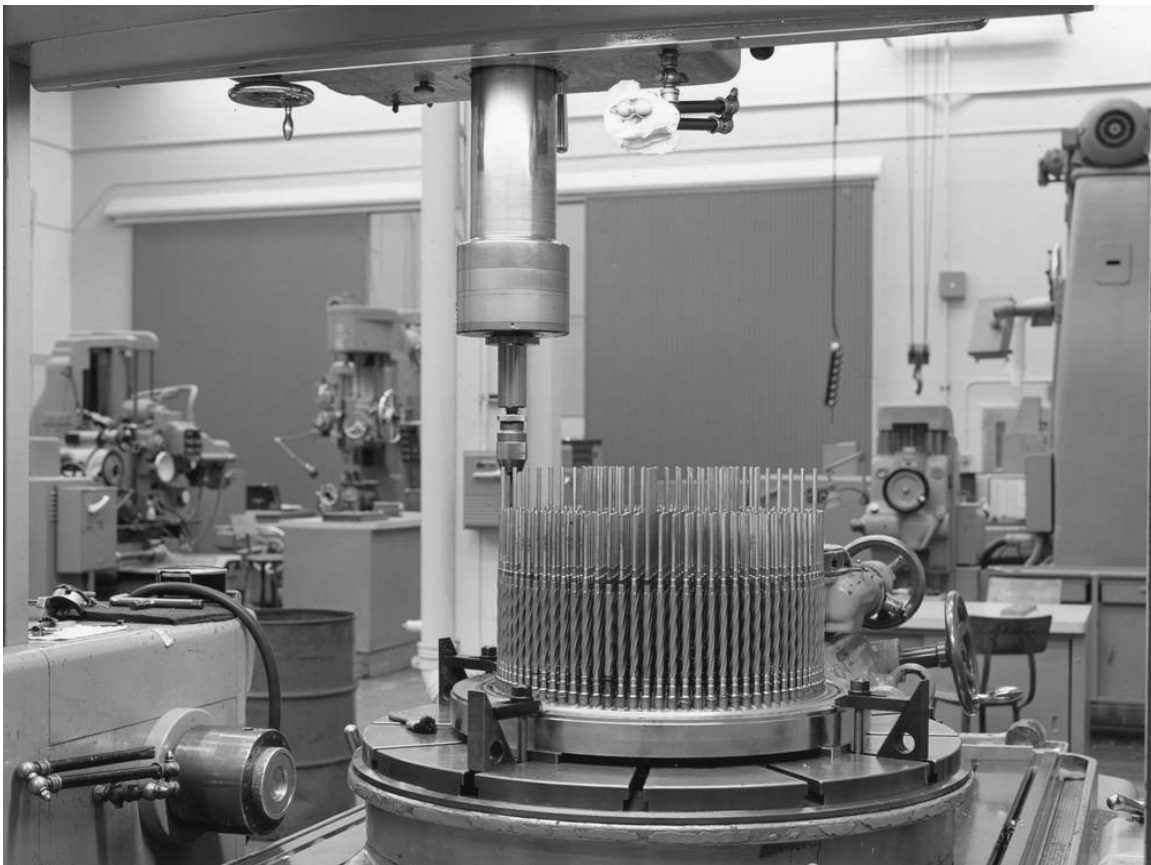
Figure C-27. Line Reaming of 600 Injector Posts for the Assembly of the Main Injector Body of the SSME, on a Precision Jig Bore, Canoga Park, 1974.  
Source: *History of the Air Force Plant Representative Office Rockwell International Corporation Rocketdyne Division 1 January – 30 June 1974.*

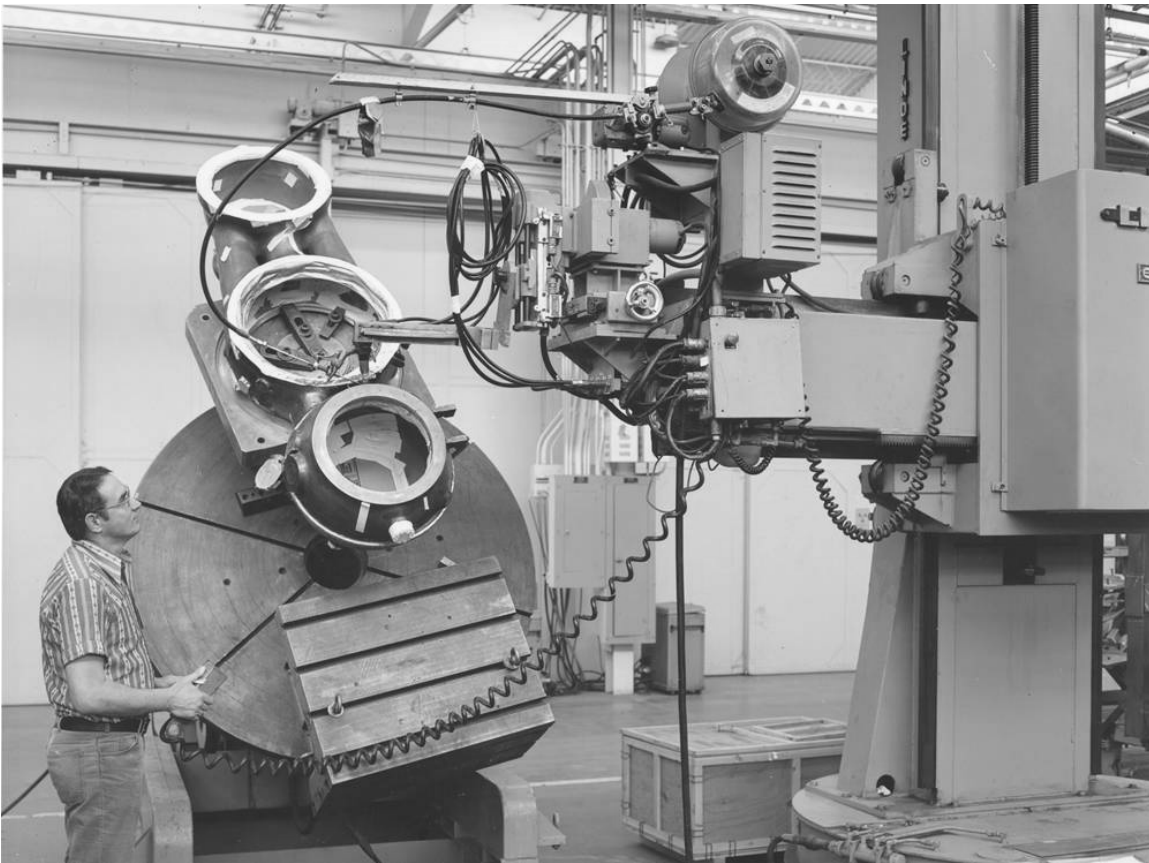
Figure C-29. A Rocketdyne technician uses the Linde Automatic Welder to apply Weld Overlay Material on the Heat Exchanger to the Manifold Joint of the SSME 0001's Solid Wall Hot Gas Manifold (SWHGM), Canoga Park, 1974.

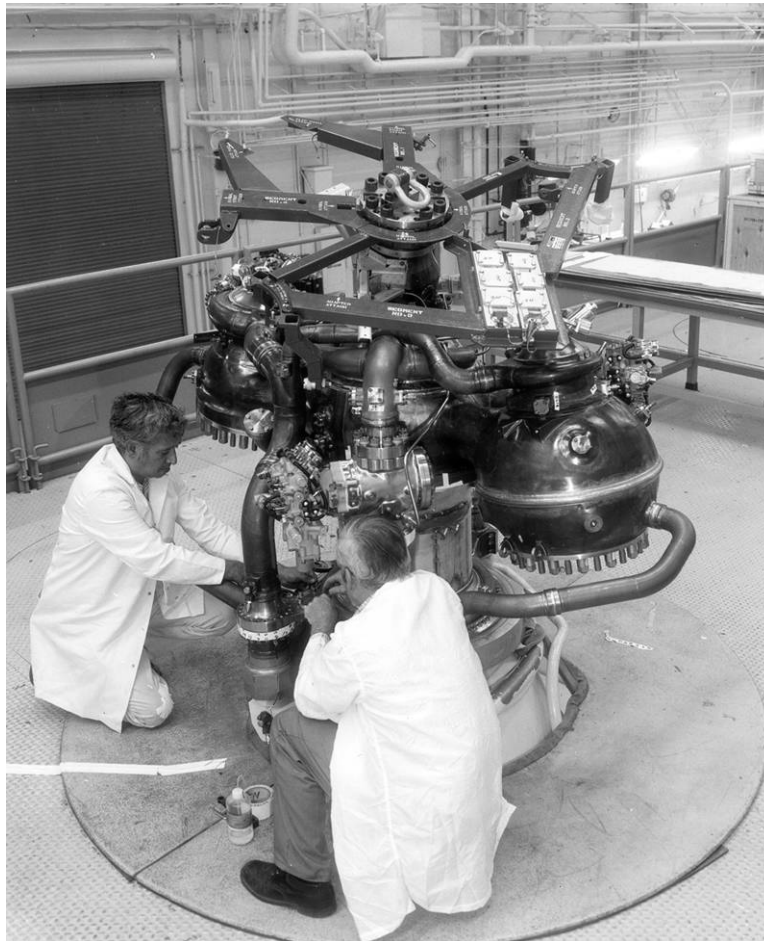
Figure C-30. Rocketdyne technicians connect a Powerhead Duct to a Combustion Device on SSME 0004, 1976.
