**Appendix C-SSME Historic Photos**

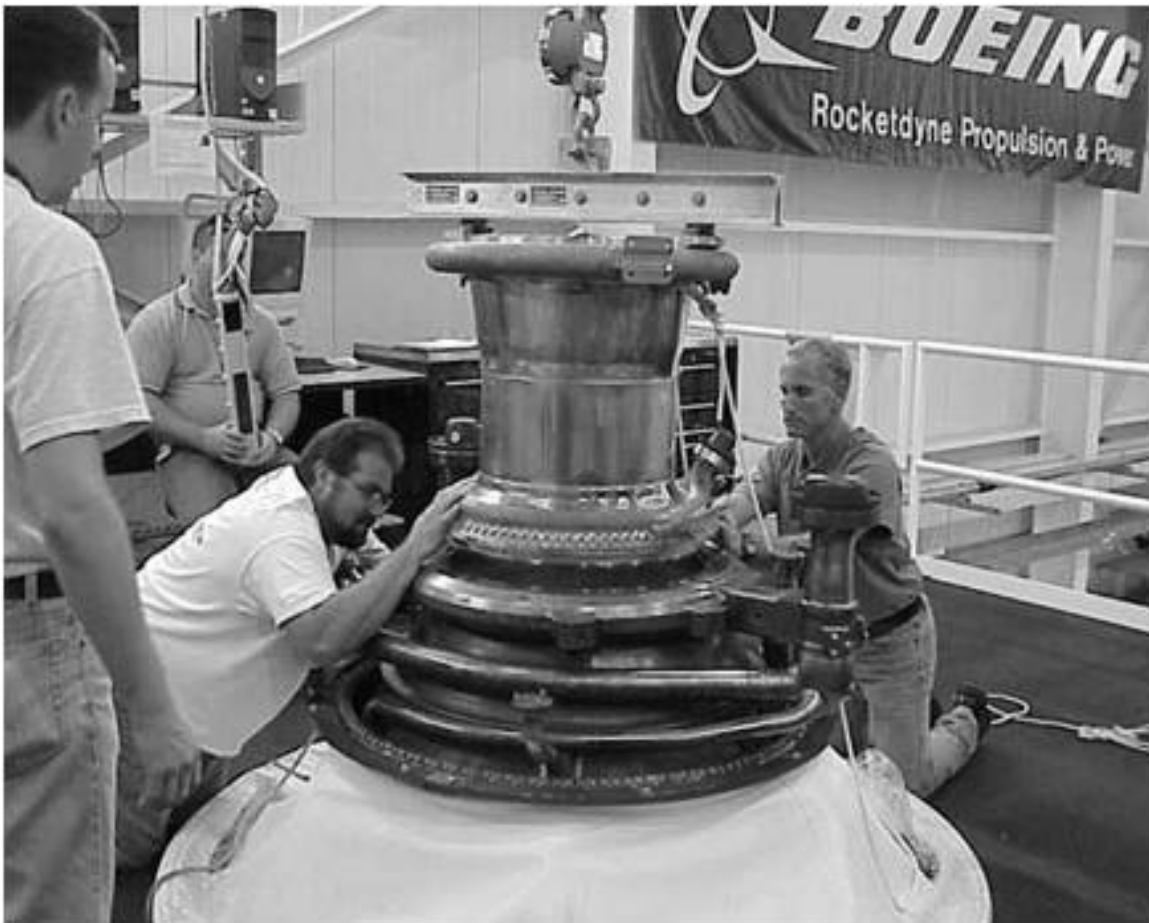
Figure C-31. Technicians attach the Main Combustion Chamber to the Nozzle in the SSMEPF at Kennedy Space Center, camera facing northeast, date unknown.  
Source: George C. Marshall Space Flight Center.

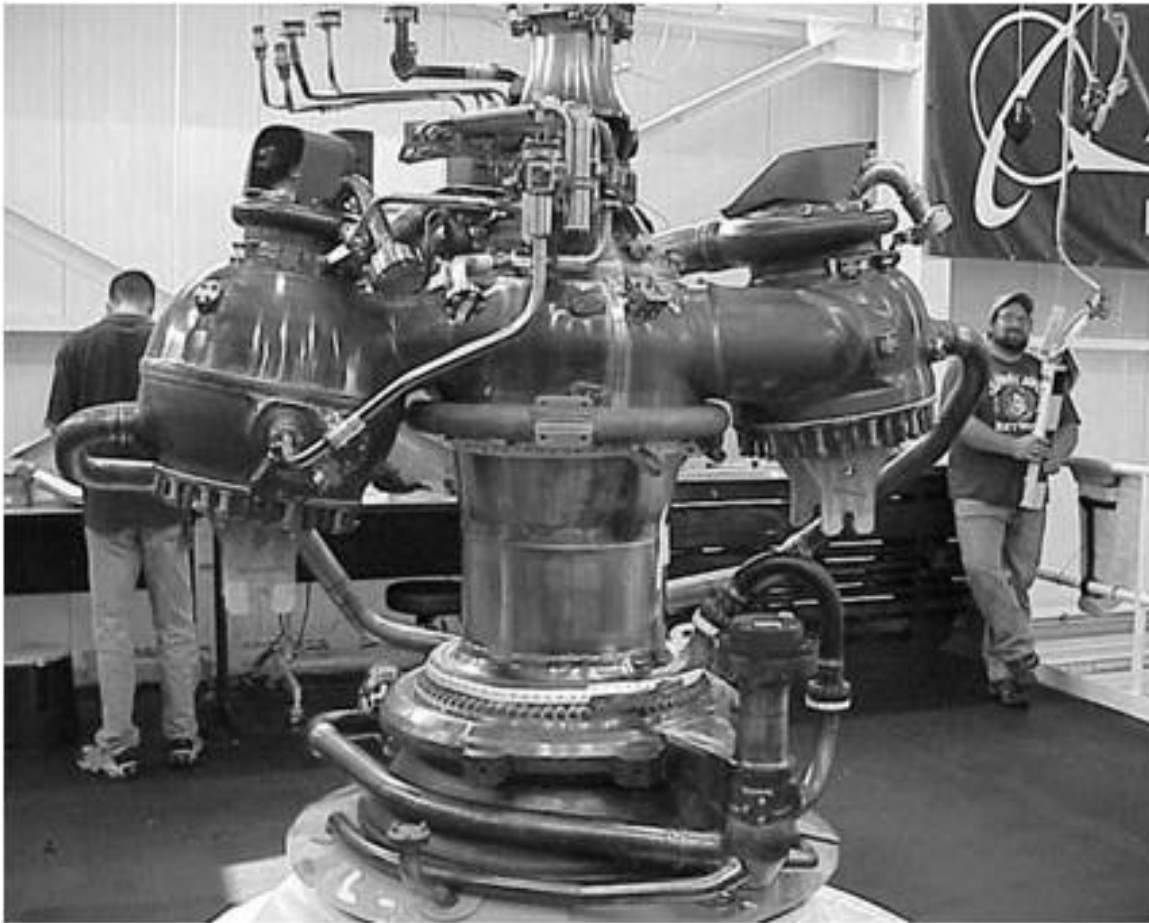
Figure C-32. Attachment of the Powerhead to the Main Combustion Chamber, SSMEPF, camera facing northeast, date unknown.

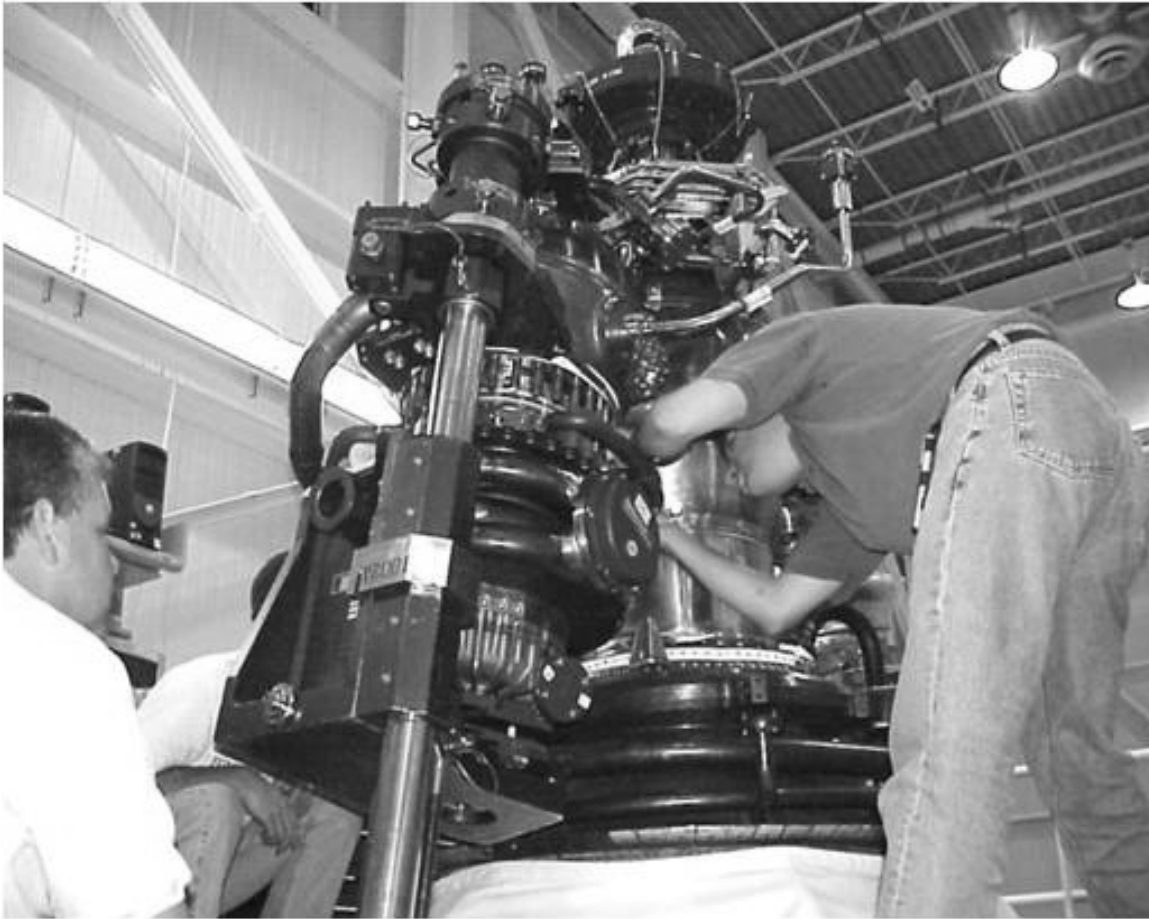
Figure C-33. A technician attaches the High Pressure Oxidizer Turbopump to the SSME, SSMEPF, camera facing northeast, date unknown.  
Source: George C. Marshall Space Flight Center.

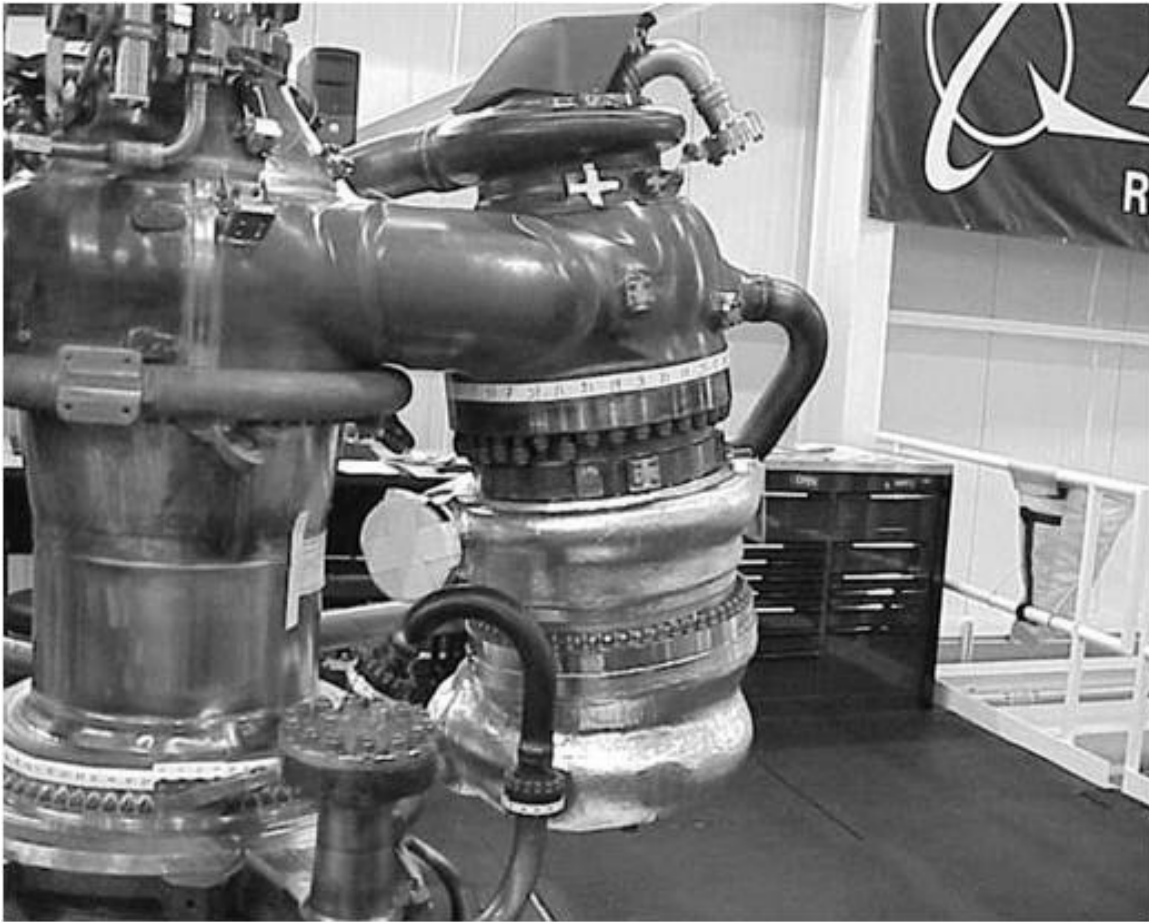
Figure C-34. Attachment of the High Pressure Fuel Turbopump to the SSME, SSMEPF, camera facing north, date unknown.

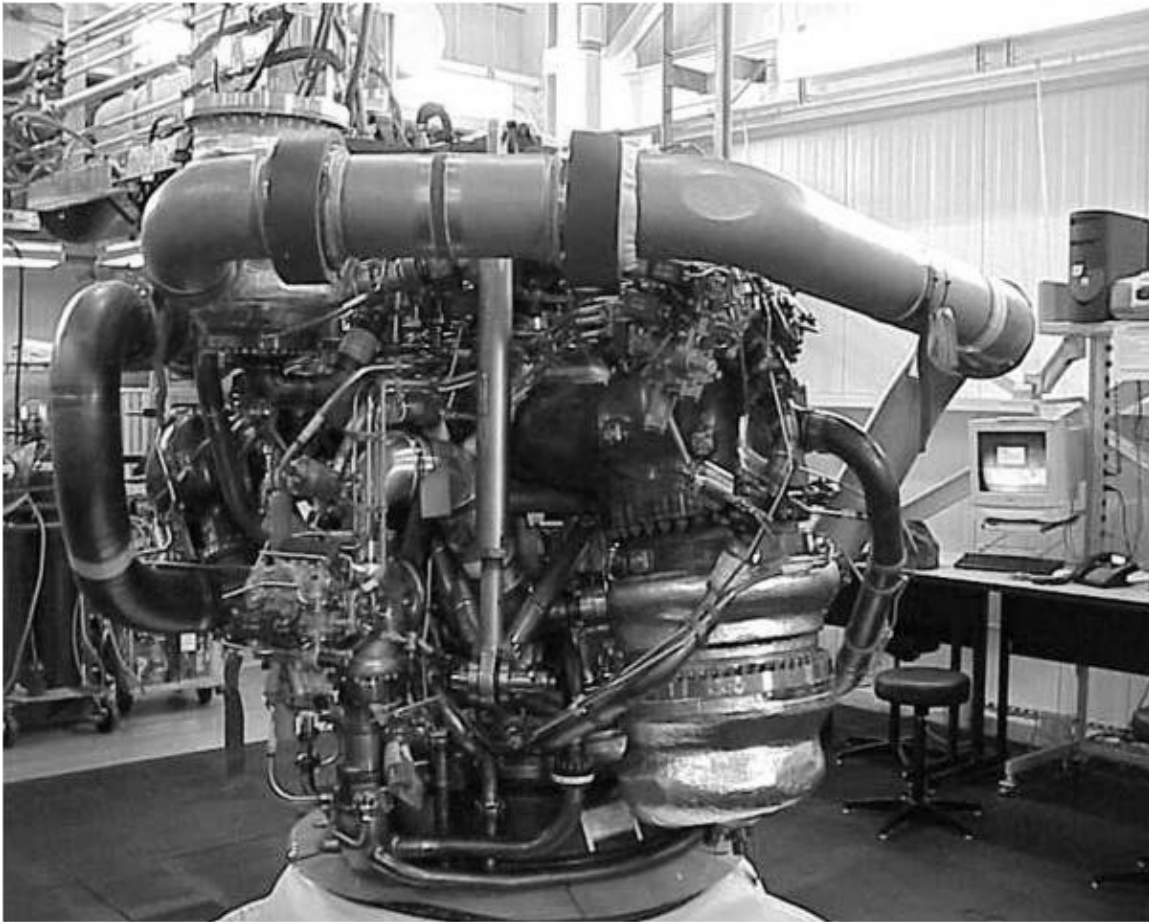
Figure C-35. Attachment of engine ducts and lines to the SSME, SSMEPF, camera facing northeast, date unknown.

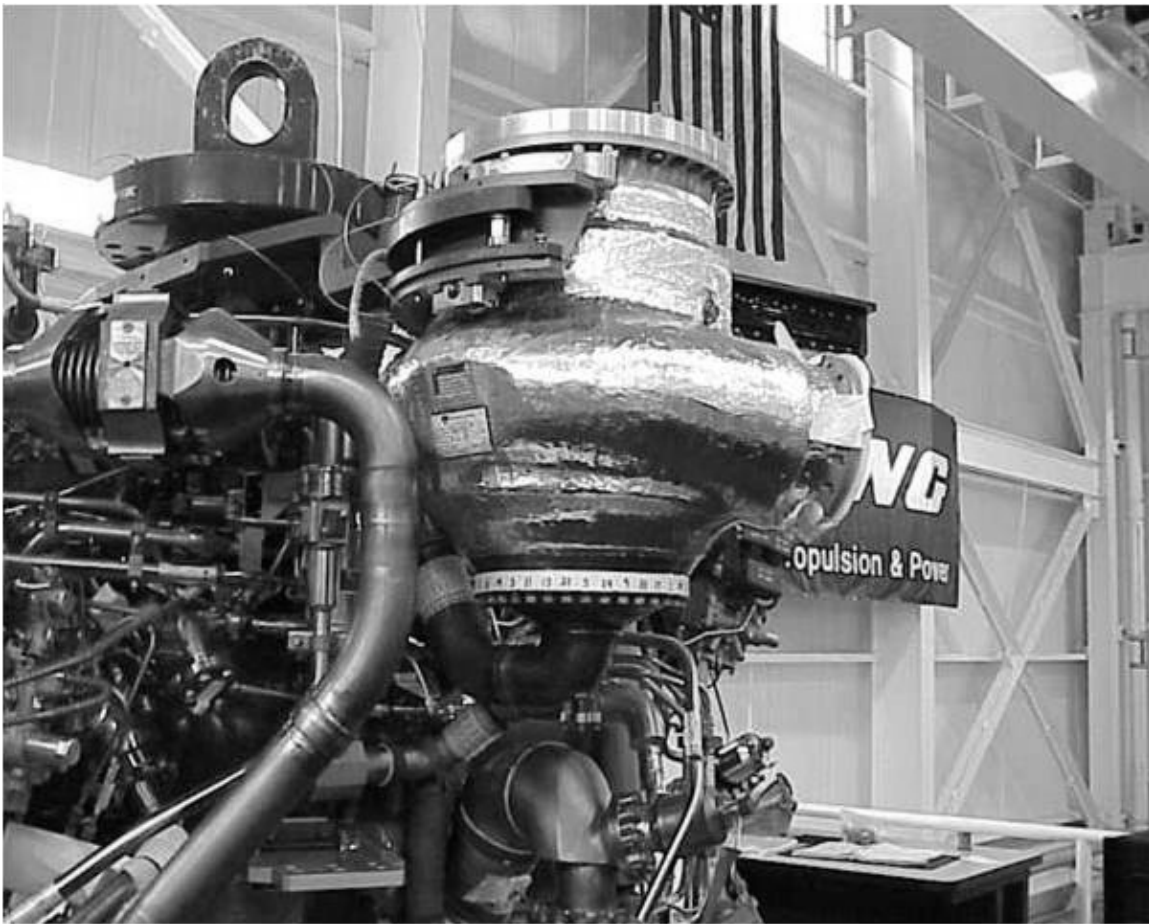
Figure C-36. Attachment of the Low Pressure Oxidizer Turbopump and the Low Pressure Fuel Turbopump to the SSME, SSMEPF, camera facing northeast, date unknown.  
Source: George C. Marshall Space Flight Center.

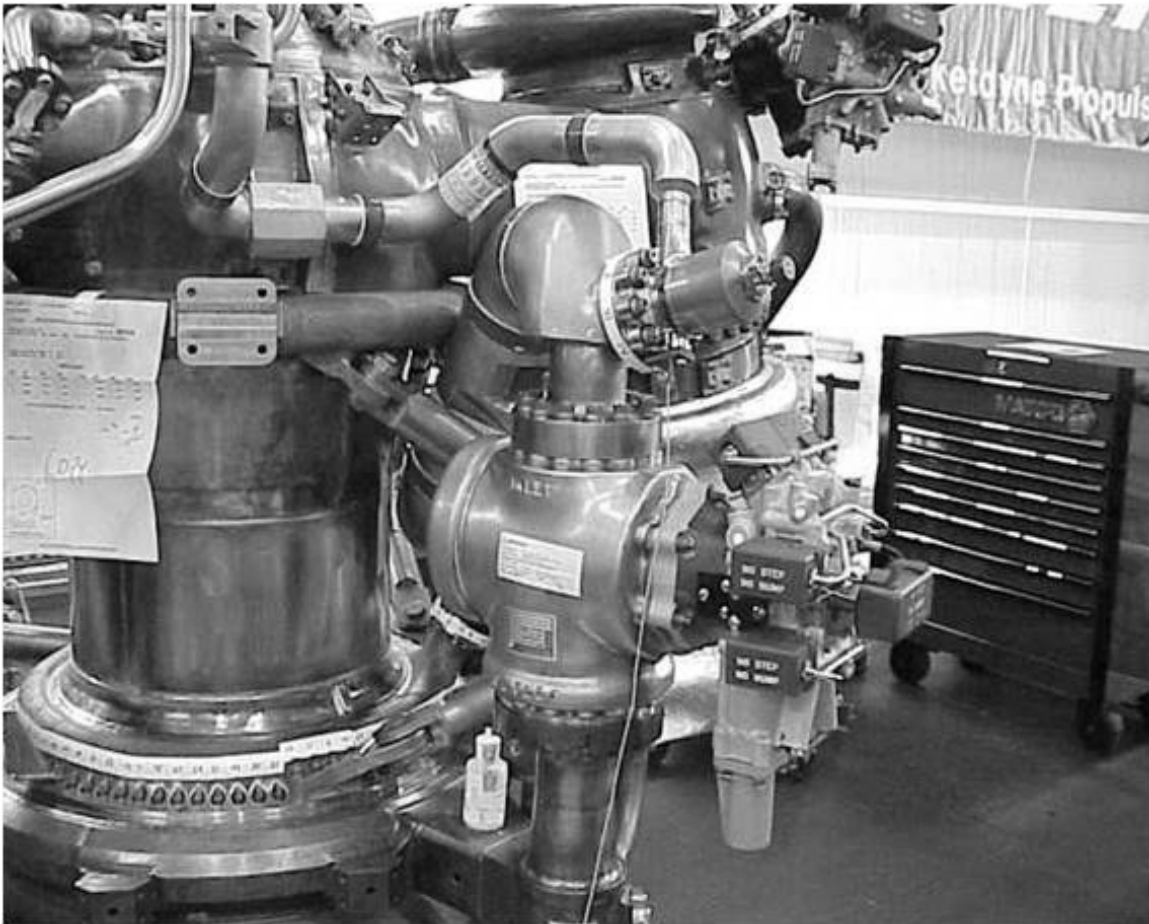
Figure C-37. Attachment of the main fuel valve and the main fuel valve assembly to the SSME, SSMEPF, camera facing northeast, date unknown.  
Source: George C. Marshall Space Flight Center.

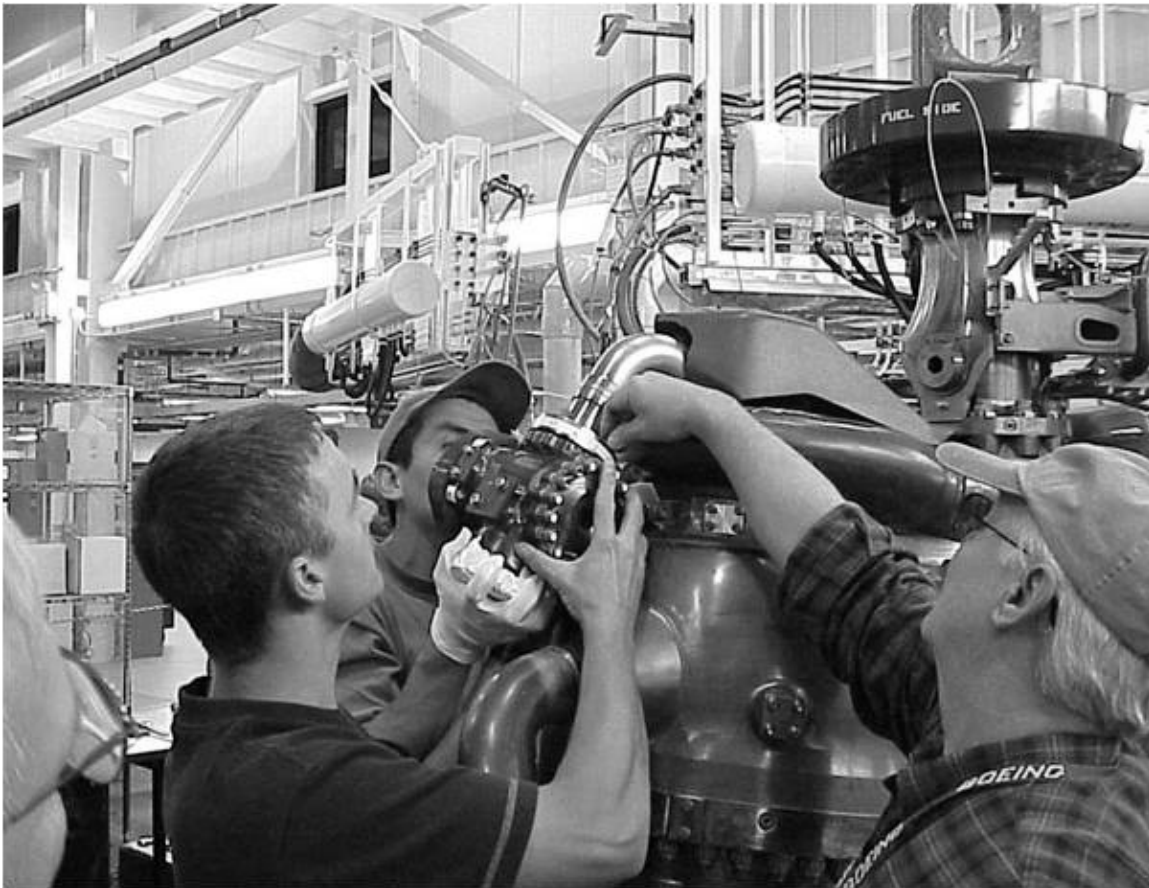
Figure C-38. Technicians attach the fuel preburner oxidizer valve and the fuel preburner oxidizer valve assembly to the SSME, SSMEPF, camera facing southwest, date unknown.  
Source: George C. Marshall Space Flight Center.

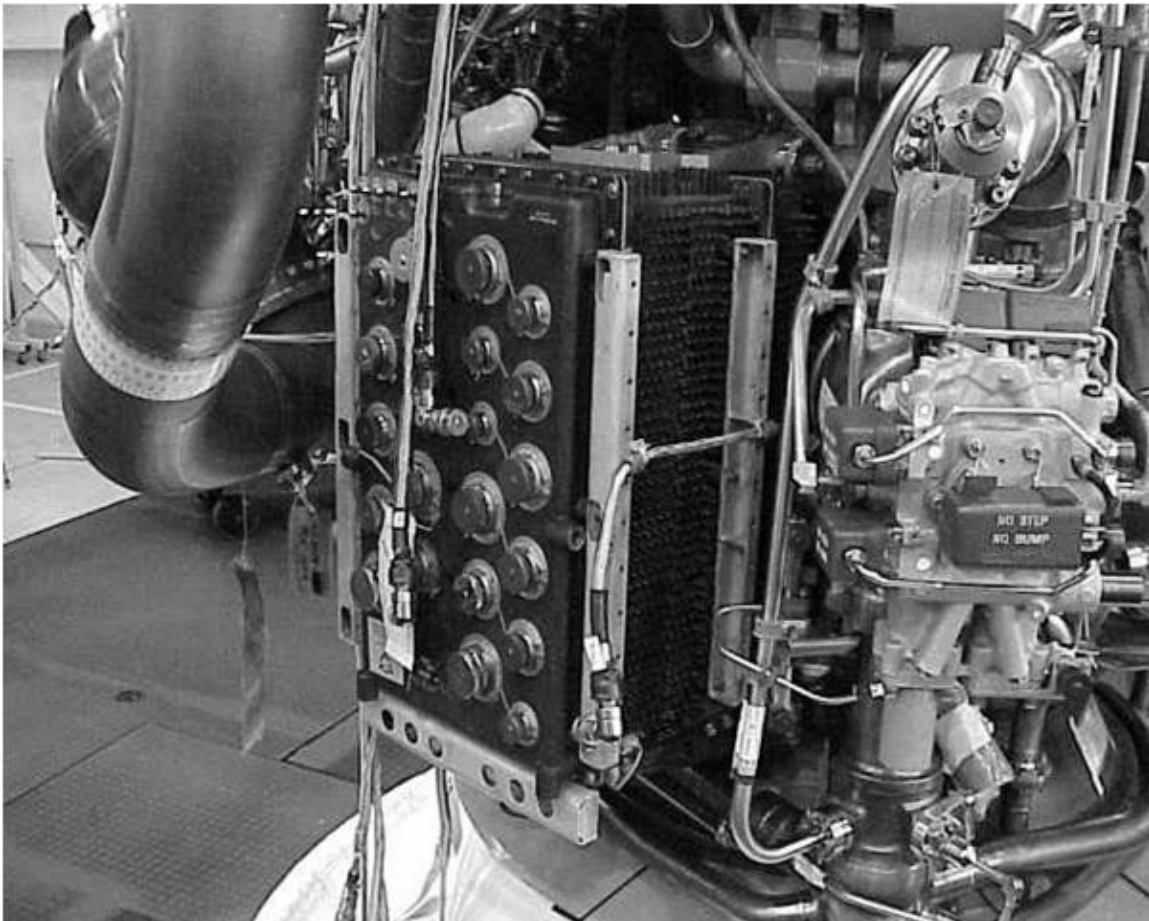
Figure C-39. Attachment of the main engine controller to the SSME, SSMEPF, camera facing northeast, date unknown.

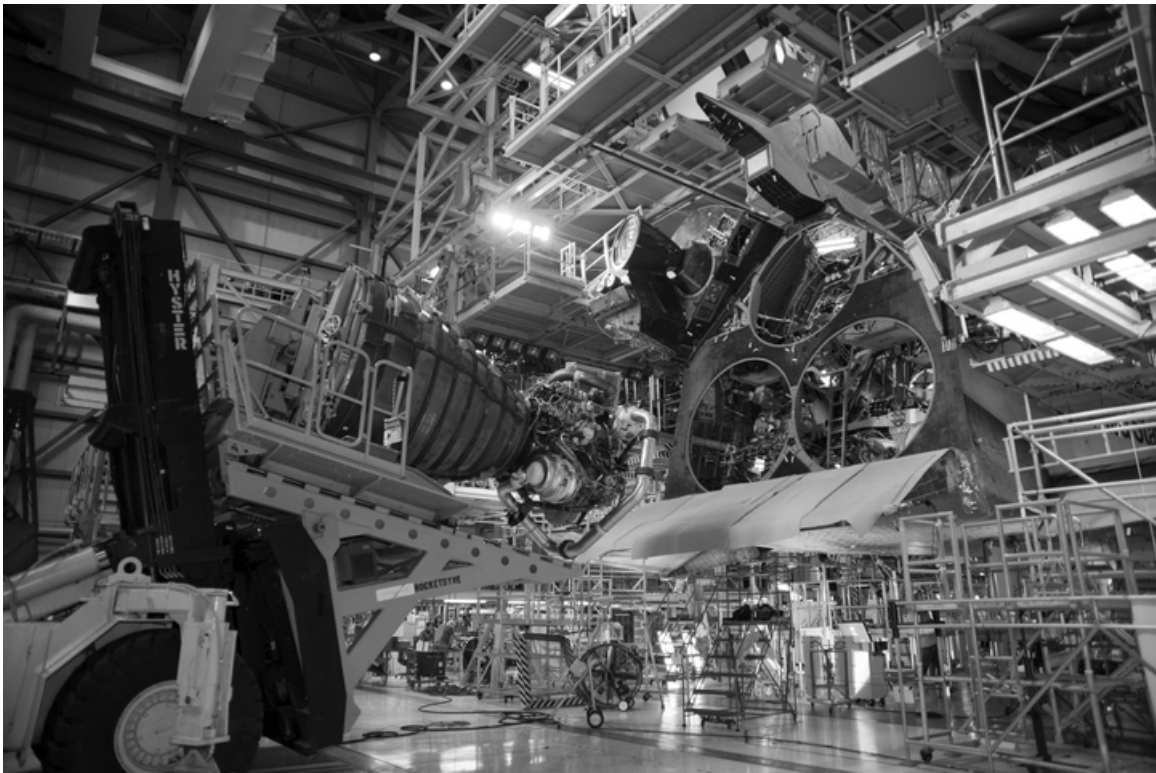
Figure C-40. Arrival of a SSME at OPF-3, Kennedy Space Center, for installation into engine position No. 1 of *Discovery*, camera facing northwest, June 30, 2010.  
Source: John F. Kennedy Space Center Online Multimedia Gallery, KSC-2010-3923.

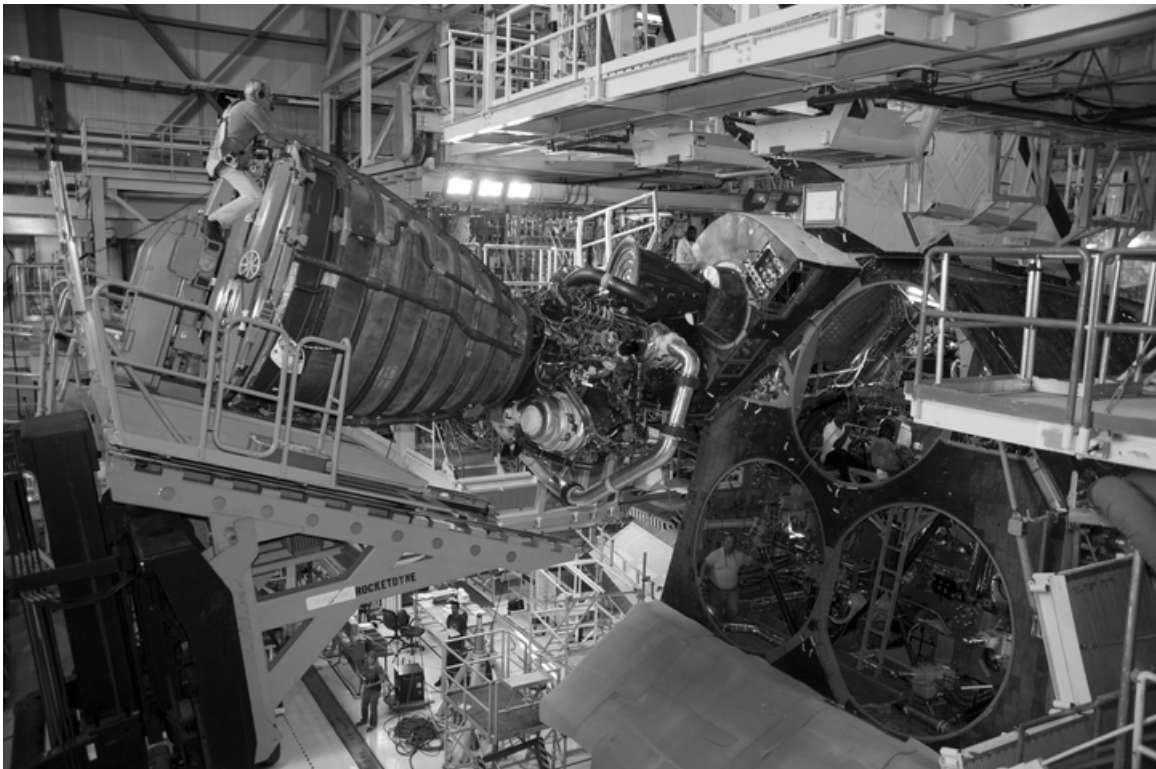
Figure C-41. A SSME lifted for installation into engine position No. 1 of *Discovery*, OPF-3, camera facing northwest, June 30, 2010.

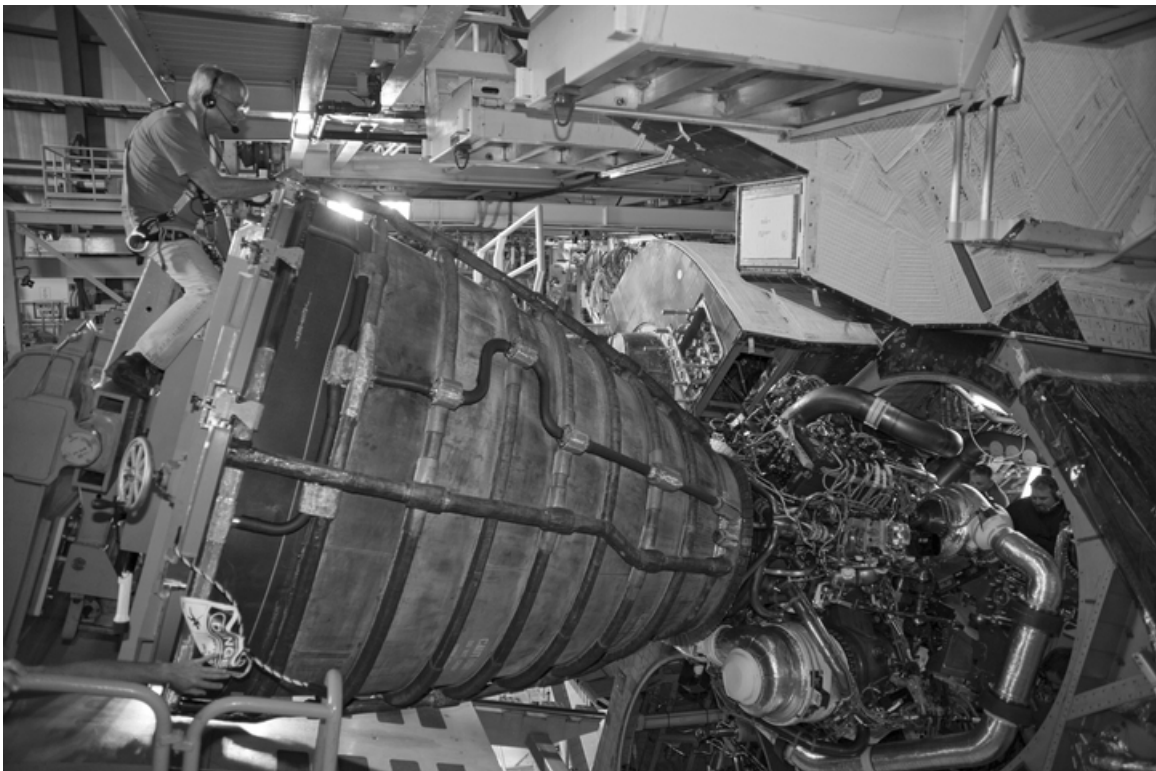
Figure C-42. A SSME being maneuvered into engine position No. 1 of *Discovery*, OPF-3, camera facing west, June 30, 2010.

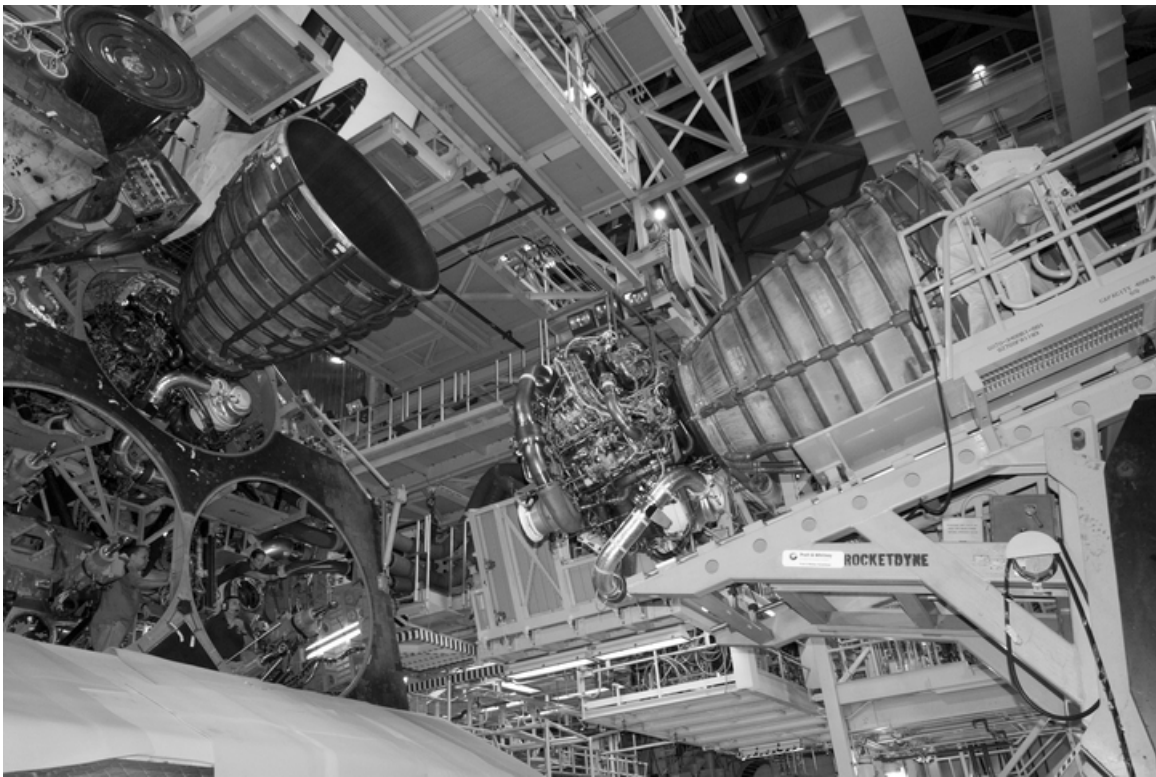
Figure C-43. A SSME lifted for installation into engine position No. 3 of *Discovery*, OPF-3, camera facing northeast, June 30, 2010.

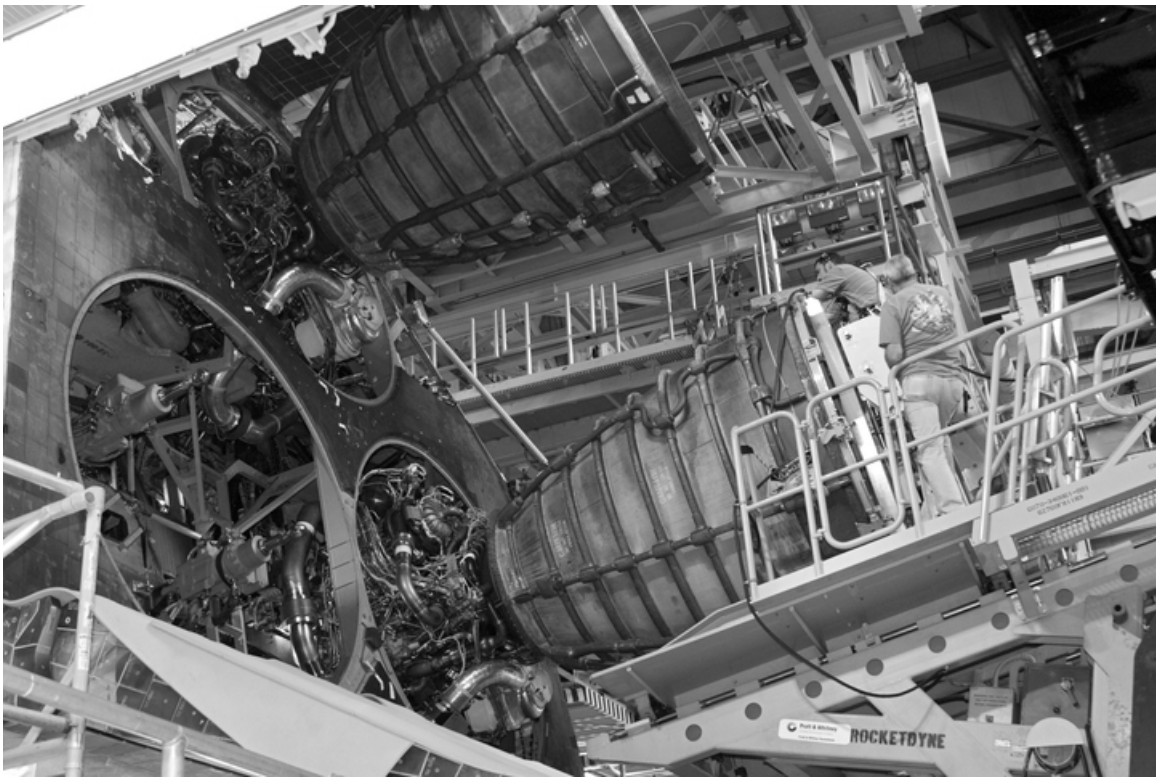
Figure C-44. A SSME being maneuvered into engine position No. 3 of *Discovery*, OPF-3, camera facing northeast, June 30, 2010.

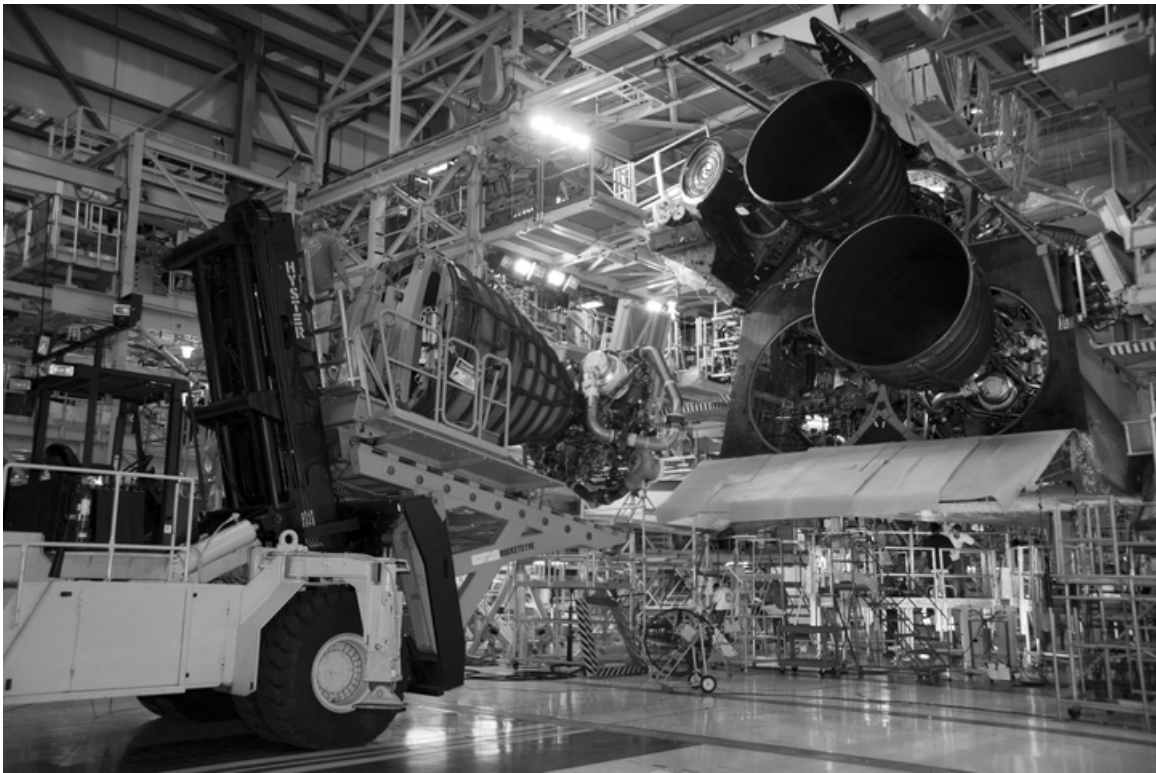
Figure C-45. A SSME being brought into OPF-3 for installation into engine position No. 2 of *Discovery*, camera facing northeast, July 1, 2010.  
Source: John F. Kennedy Space Center Online Multimedia Gallery, KSC-2010-3933.

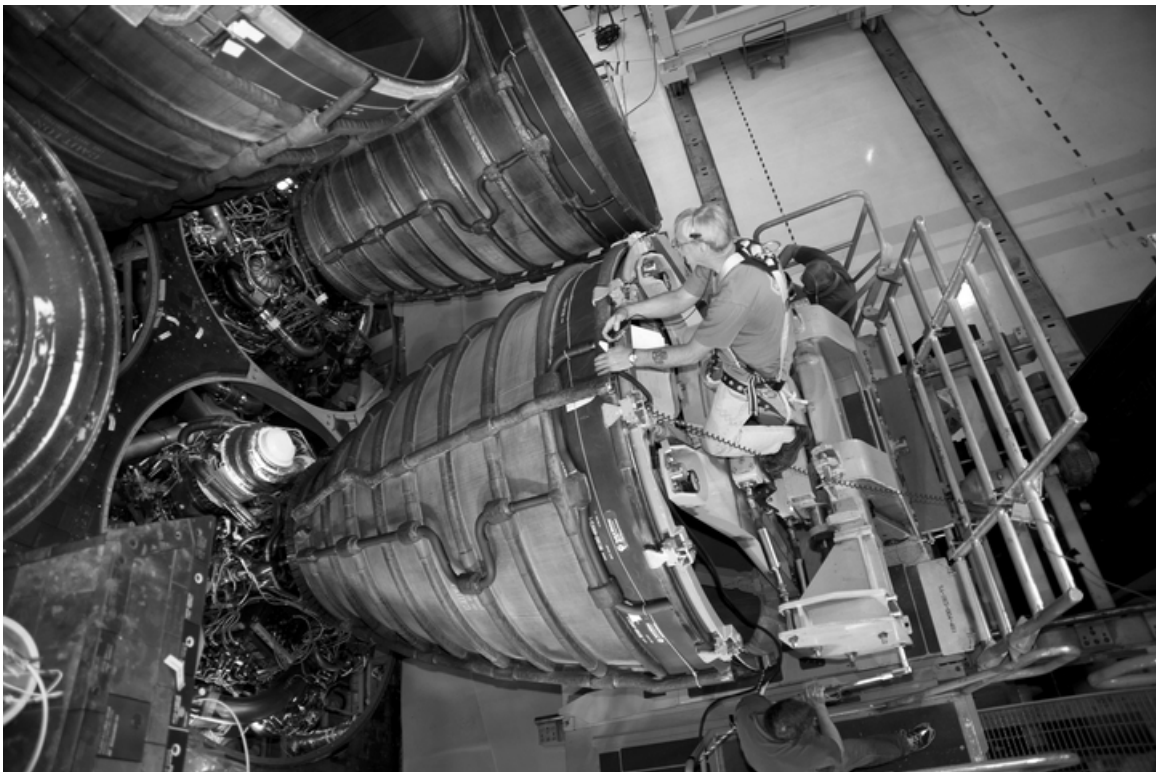
Figure C-46. A SSME being maneuvered into engine position No. 2 of *Discovery*, OPF-3, camera facing northeast, July 1, 2010.
